Insured:	Harbor Bay Community Development District
Insurer:	Florida Insurance Alliance
Policy Number:	100124618
Policy Term:	October 01, 2024 – October 01, 2025
Date of Loss	October 09, 2024
Cause of Loss:	Hurricane Milton
Loss Location:	Multiple (Per Property Schedule)
McLarens File:	009.023748.MI

McLarens File 009.023748.MI
Harbor Bay CDD

IX. CONCLUSIONS AND OPINIONS

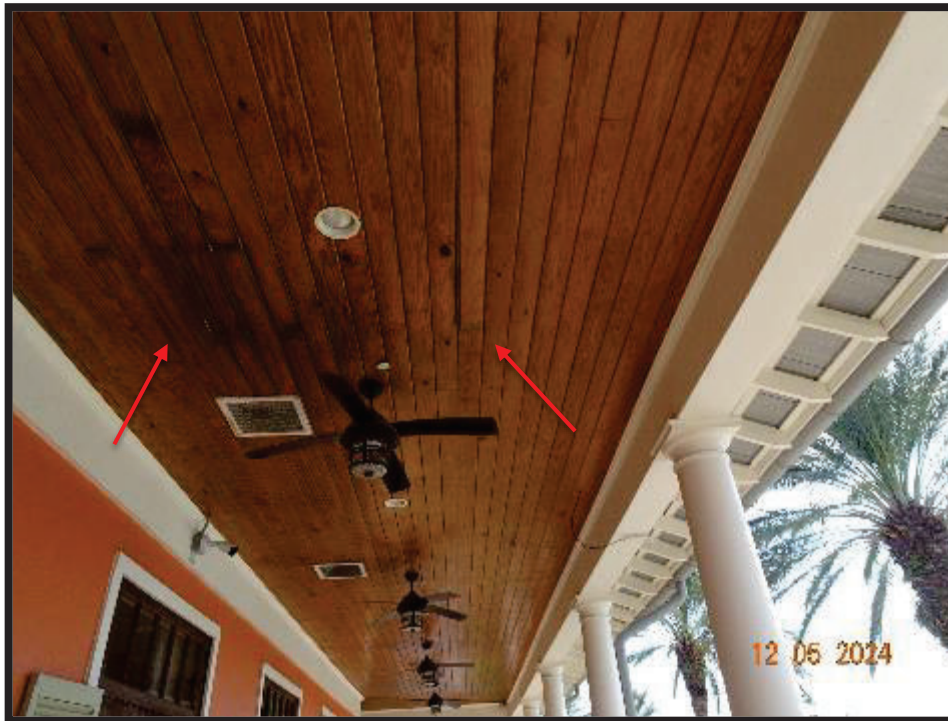
- c. The conditions observed to the ceiling wood tongue and groove planks along the rear patio canopy along the second floor of the Main Building are associated with long-term moisture conditions based on the repair work associated with the substrate conditions found above this area from the roof attic access

3. There was no access to the roof covering during Halliwell's inspection.
4. Along the exterior rear patio area along the second floor, there were several tongue and groove planks along the ceiling that were observed to have been dislodged.

7. There was visible evidence of past repairs performed to the ceiling areas above the rear canopy area where the tongue and groove planks were observed to have moisture damage conditions accessed and observed through the attic space of the upper roof level catwalks.

Photo 2 View of the rear patio canopy along the second floor depicting damage conditions to the wood tongue and groove planks along the ceiling.

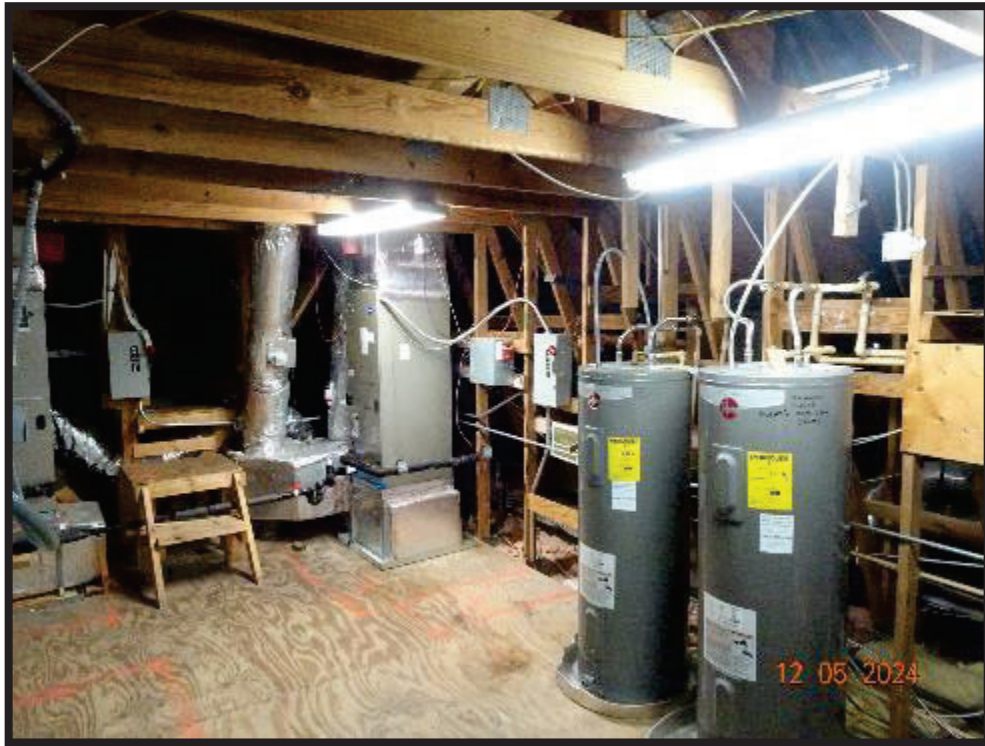
Photo 3 View the Mezzanine area along the second floor above the Fitness Center.

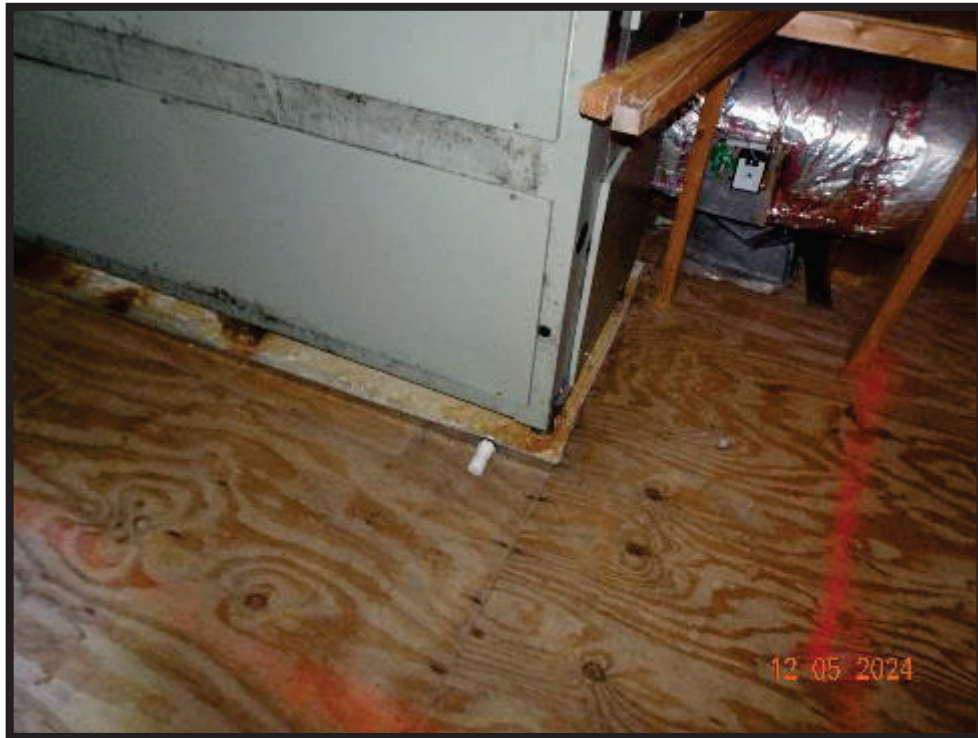
10. There was some staining around ceiling diffusers in the Meeting Room.
11. The mezzanine area was equipped with mechanical units having drain pans.

Photo 4 View of drain pans along the bottom of mechanical equipment in the Mezzanine area.

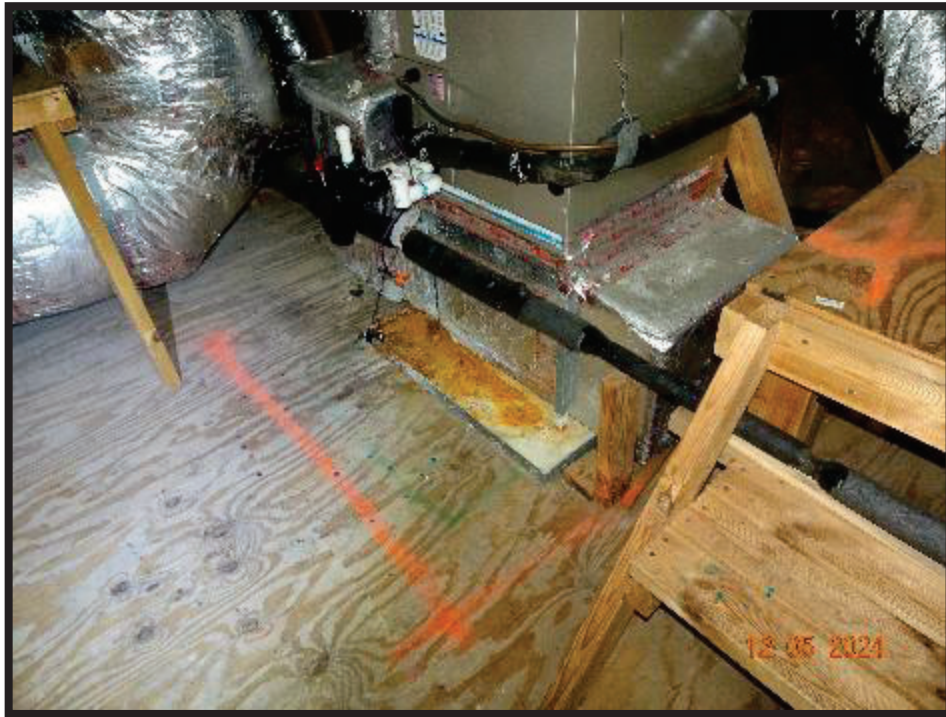
Photo 5 View of drain pans along the bottom of mechanical equipment in the Mezzanine area.

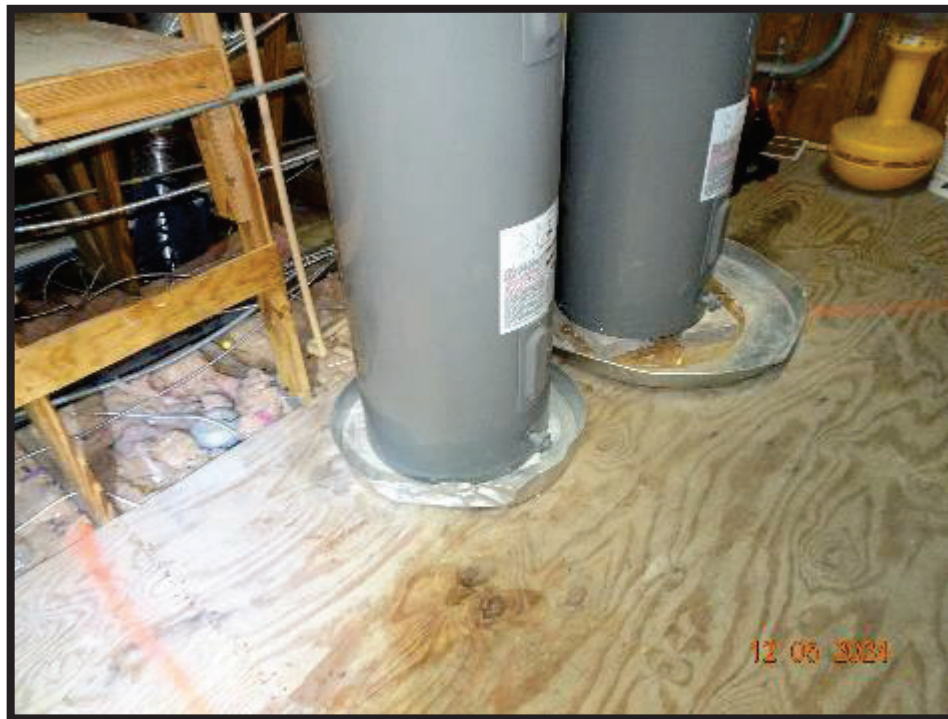
Photo 6 View of drain pans along the bottom of water tanks in the Mezzanine area. Note drain pans do not have an overflow pipe.

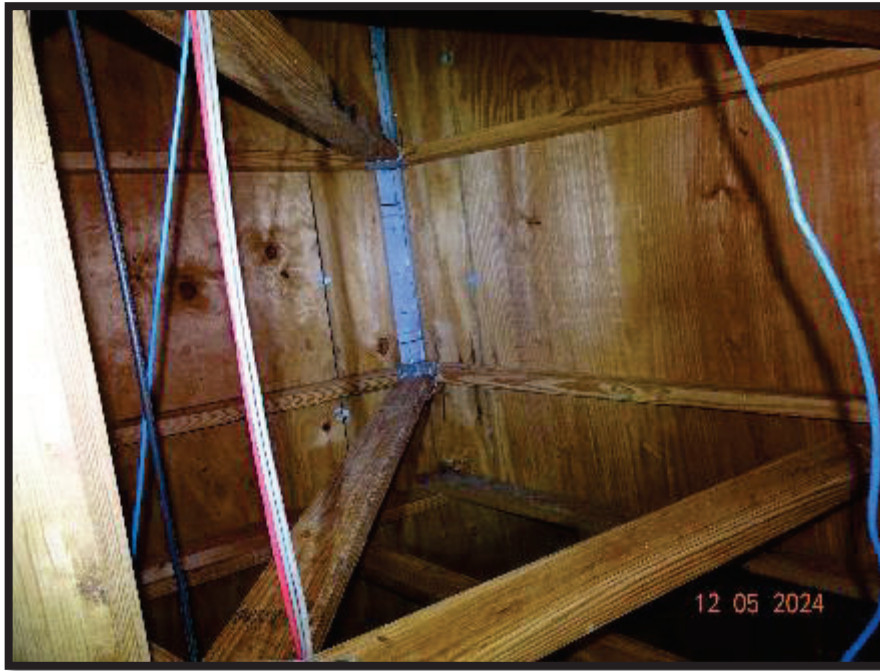
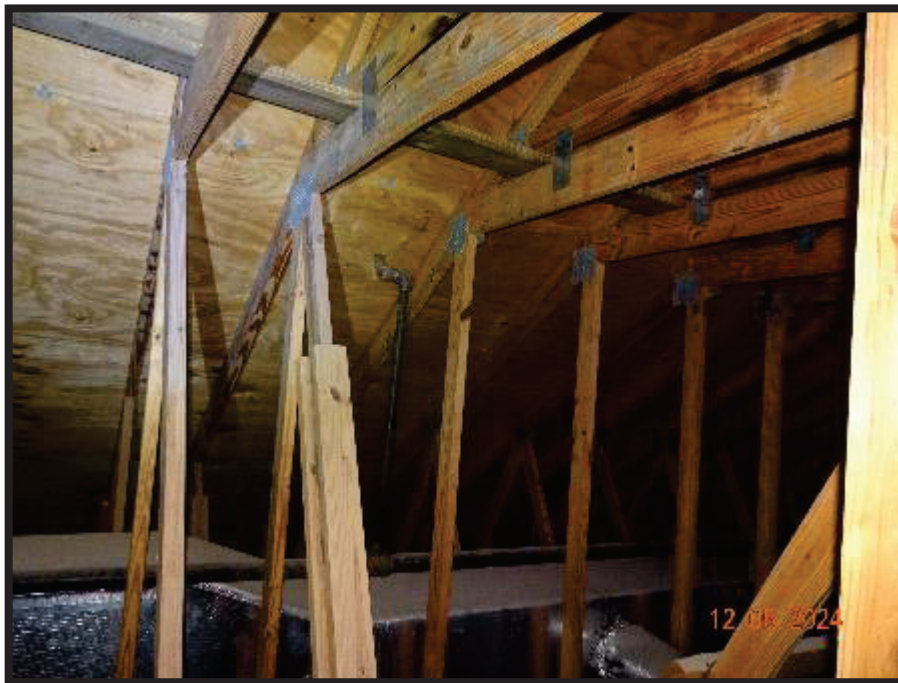
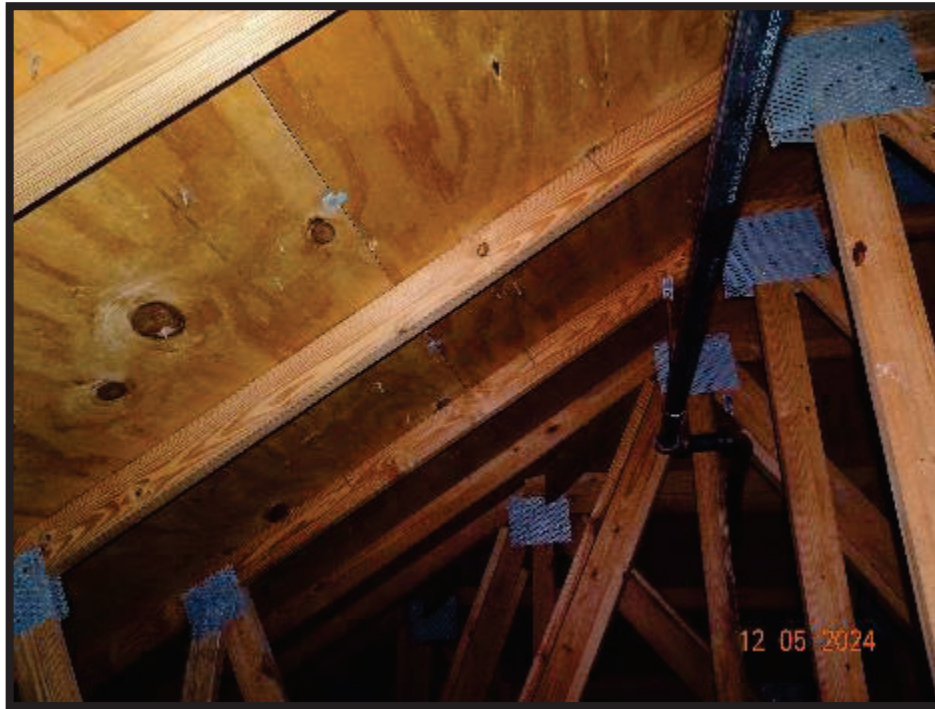
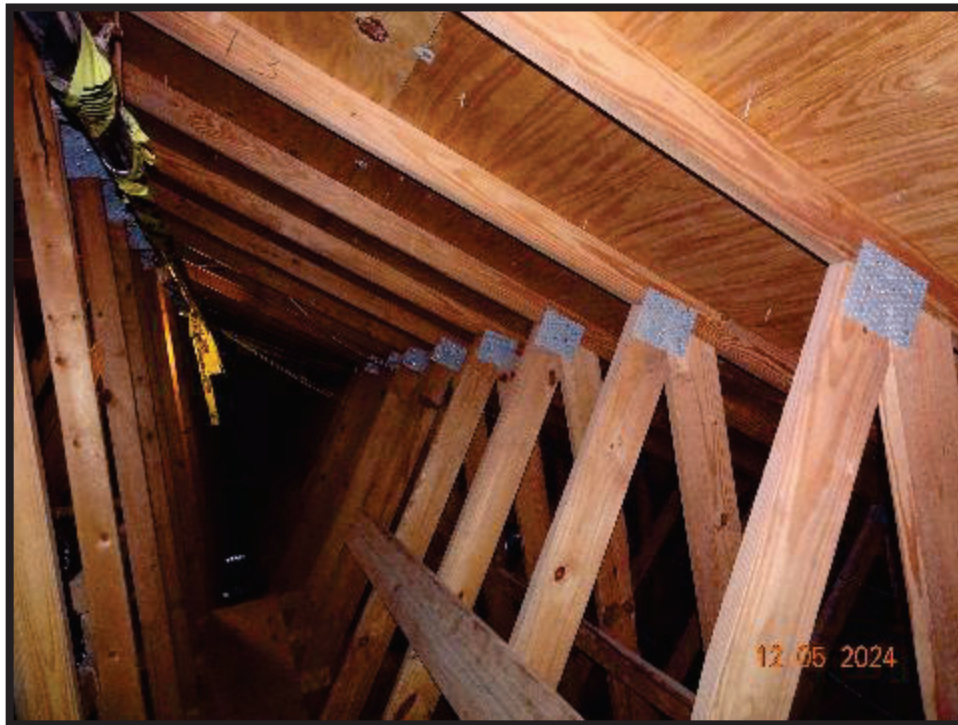
8. There was no visibly apparent evidence of moisture stains along the underside plywood sheathing at the roof trusses above the mezzanine/fitness area.

Photo 7 View of wood truss framing within the Mezzanine area. No visibly apparent evidence of water stains on the underside of the plywood sheathing to suggest moisture intrusion from the roof.

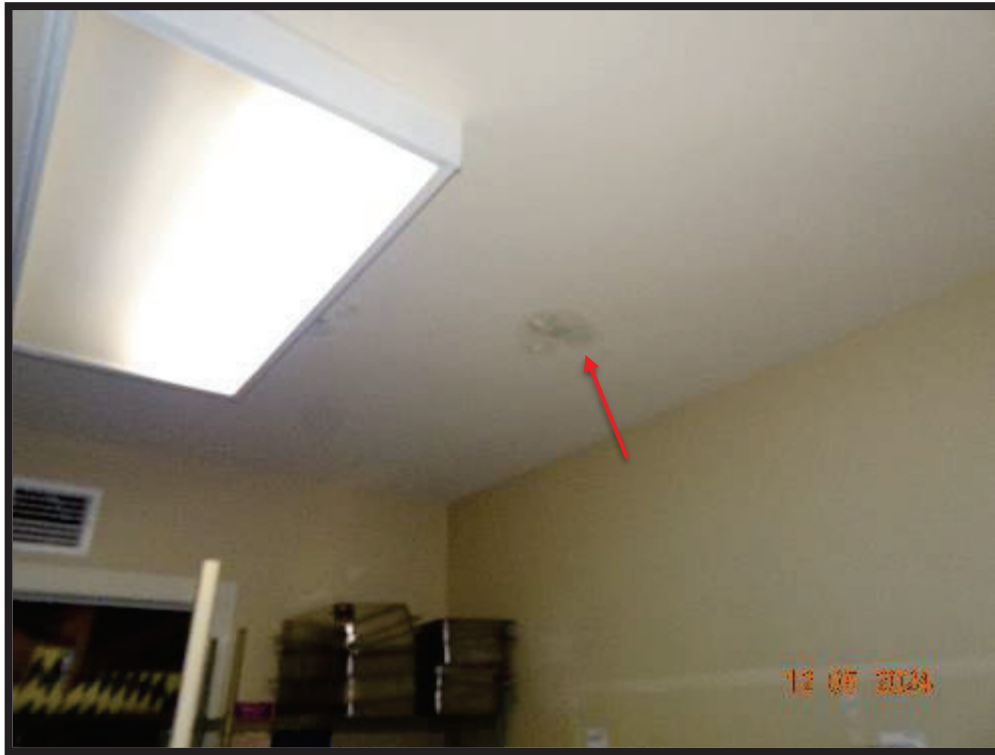
9. There were some moisture stains observed along a drip ceiling panel at the entrance of the mezzanine. HVAC lines and diffuser were directly above and around the vicinity of the stained drop ceiling panel.

Photo 11 View of stain along ceiling drywall along the entrance of the Mezzanine area.

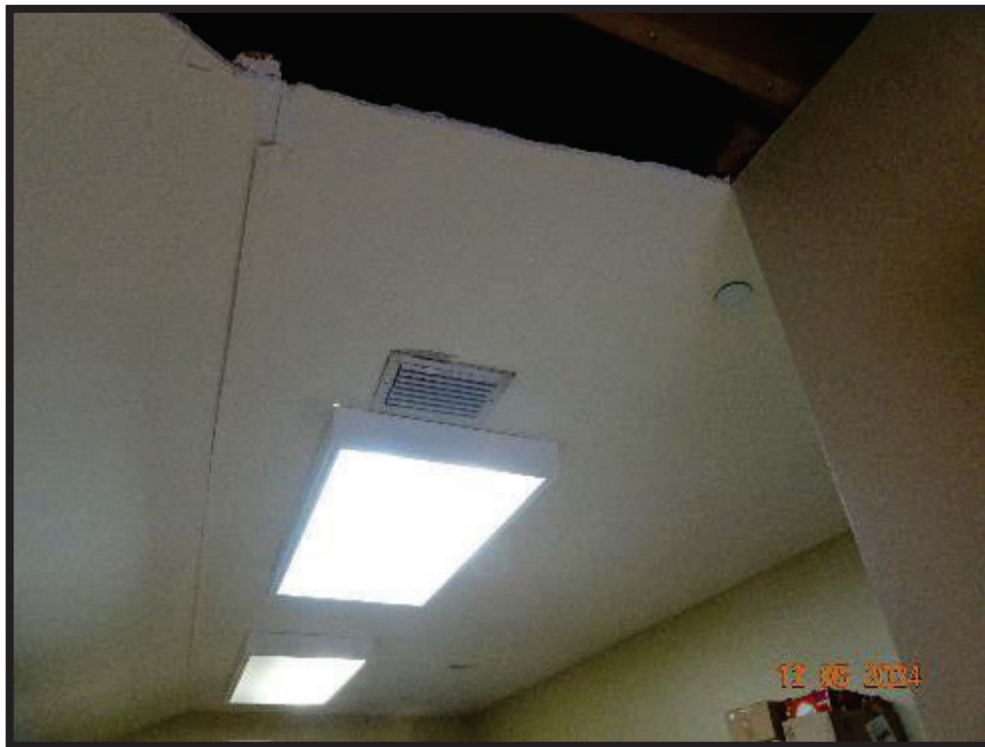
Photo 12 View of stain along ceiling diffuser along the ceiling at the entrance to the Mezzanine area.

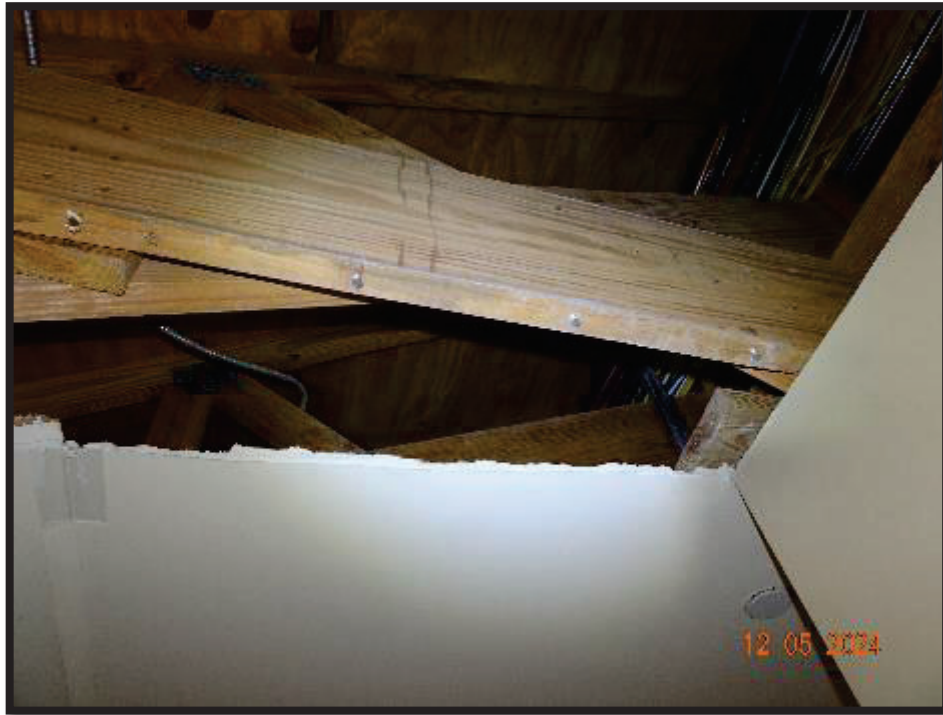
Photo 13 View of the underside of plywood above the ceiling area that was observed to have some stains. No visibly apparent evidence of water intrusion from the roof. Stains possibly from HVAC ducts and equipment.

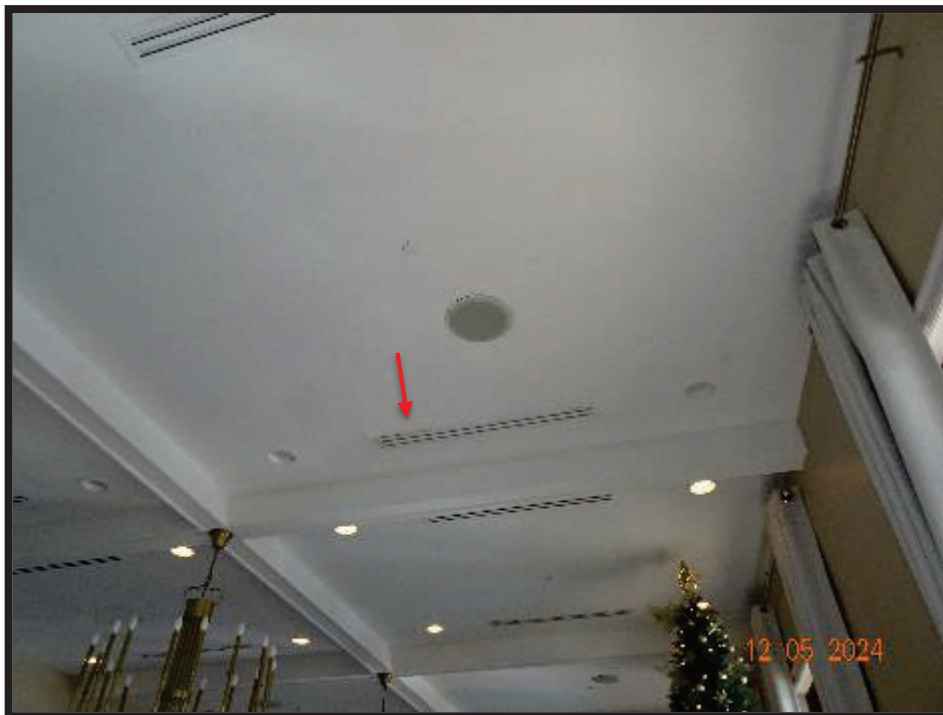
- d. The conditions found in the ceiling drywall around diffusers in the Meeting Room more likely than not are related to the air conditioning of the space and the condensation that forms around cold diffusers during the operation of the HVAC equipment and the conditioning of the interior space daily. There was no visibly apparent evidence of moisture intrusion from the roof structure above these ceiling areas.

Photo 14 View of stains along linear diffusers along the ceiling in the Meeting Room.

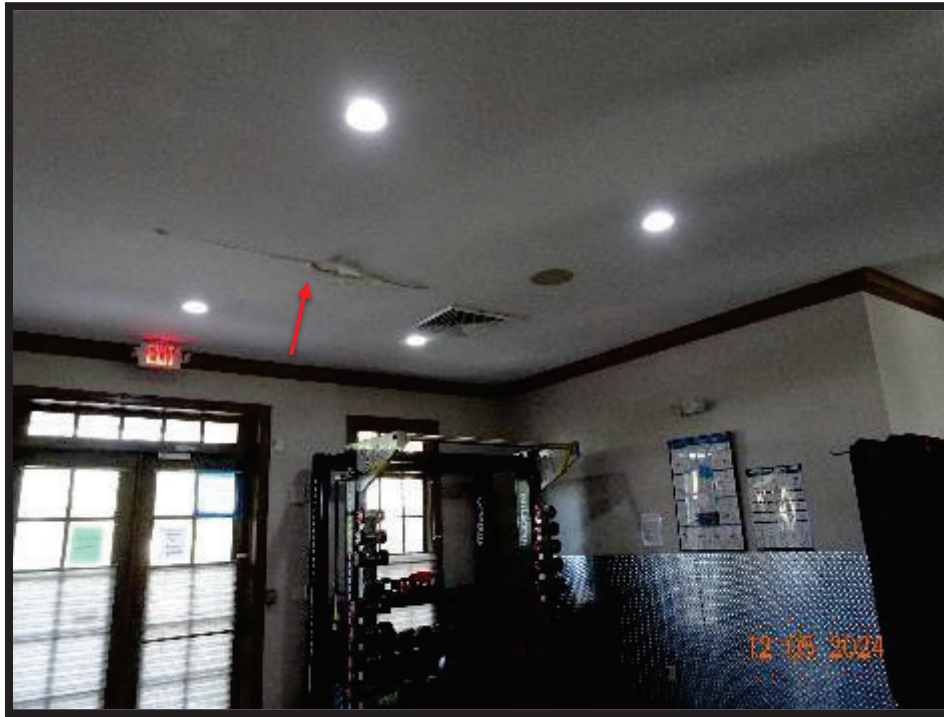
- e. The damage conditions to the south areas of the ceiling drywall in the Fitness room are not a condition associated with the weather effects from Hurricane Helene or Milton.

Photo 15 View of damage conditions along ceiling drywall in Fitness Center. Area outside of Mezzanine footprint.

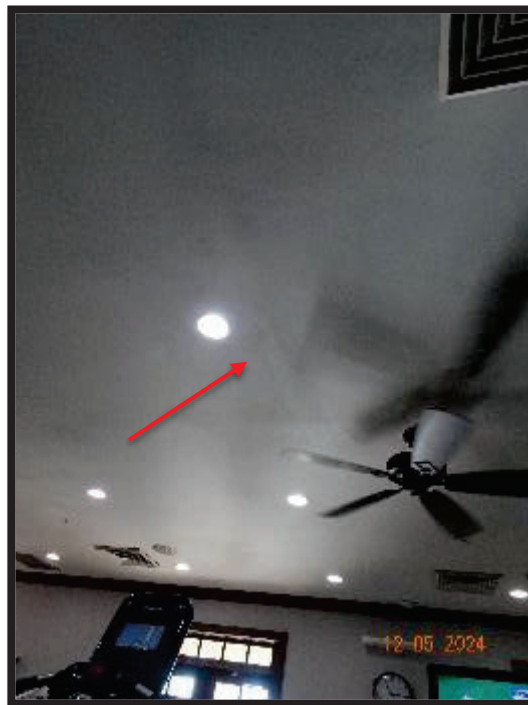
12. There was moisture staining and evidence of past repairs to the ceiling areas of the fitness room located below the vicinity of the mezzanine area.
13. In addition, there were paint peeling damage conditions along the fitness room ceiling area located in a lower gable roof section where the mezzanine area does not extend over the fitness room.
14. The anaerobic room ceiling drywall was observed to be separating. In addition, the crown molding along the perimeter of the room was observed to also be separating along the seam joints.

Photo 16 View of repairs to ceiling drywall in Fitness Center. The area below the Mezzanine.

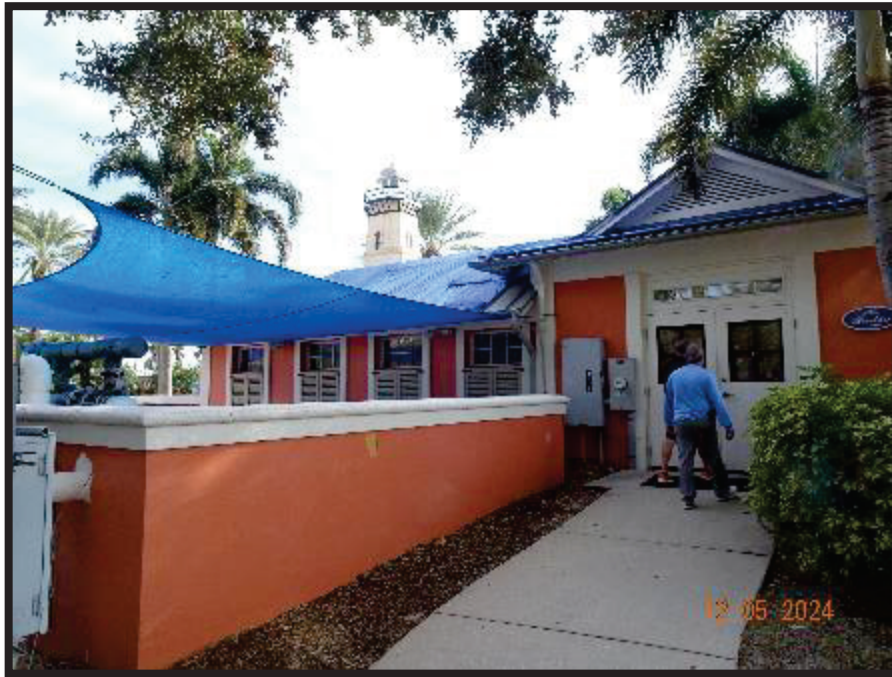
Photo 17 View of the front entrance to The Dockers Building. Note roof was also covered with a tarp.

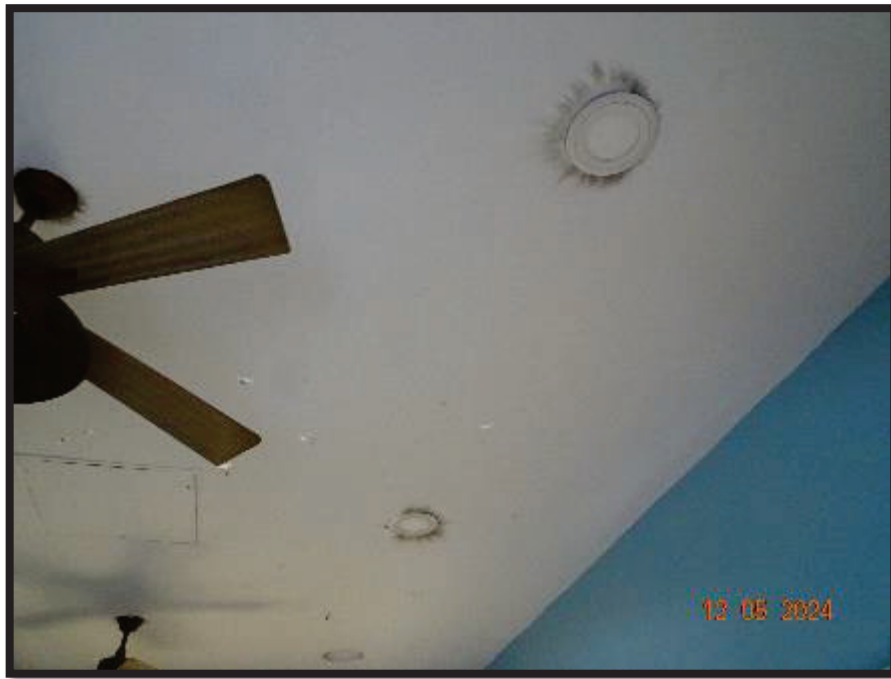
- g. The black staining at interior ceiling areas at the Dockers Building along recess light fixtures appears to be related to moist air being drawn out of the attic space through ceiling openings resulting in apparent mold and mildew conditions to form around light fixture openings. There was no visibly apparent evidence of moisture intrusion within the interior space that can be attributed to wind effects from Hurricane Helene or Milton.

Photo 19 View of black staining around recess light fixtures at the ceiling in the Dockers Building.

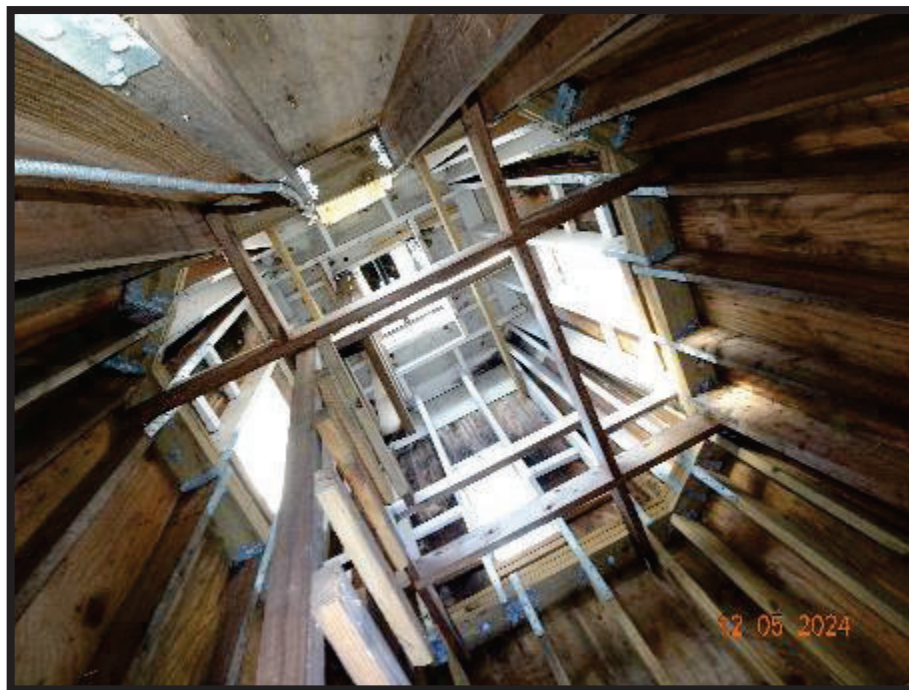
- i. The moisture intrusion along the backside of wood framing including plywood near the upper areas of the lighthouse structure and around window locations are conditions associated with long-term weathering effects from daily environmental conditions and effects that the Lighthouse Tower has been subject to and not conditions associated with wind effects from Hurricane Helene or Milton.

20. The interior face of the plywood adjacent to the windows was observed to have black staining suggesting mold and long-term moisture intrusion.
21. The wood framing composing the light fixture structure on top of the tower was observed to be deteriorated and degraded from wood decay.

Photo 24 View of interior surfaces of framed wall of Lighthouse Tower. Note black substance stains along the face of plywood and some of the wood framing.

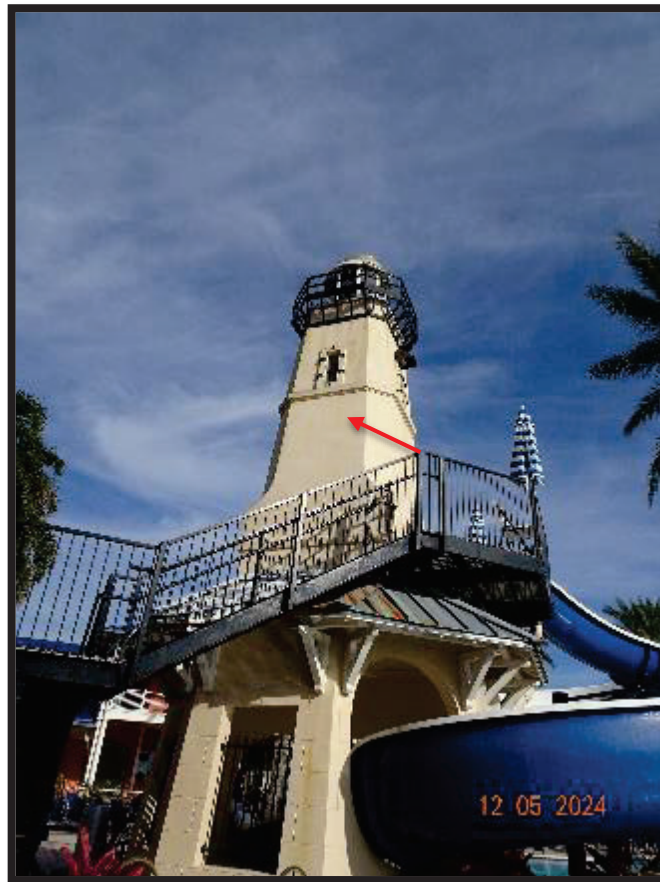
17. The exterior finishing of the walls was observed to have a painted stucco finish. There was some staining observed below decorative metal frames attached to windows. In addition, there were some hairline horizontal cracks observed along the exterior face of the wall. The staining was along exterior wood framed sections of walls.

Photo 25 View of stains along the exterior face of painted stucco finish below metal bars around windows.

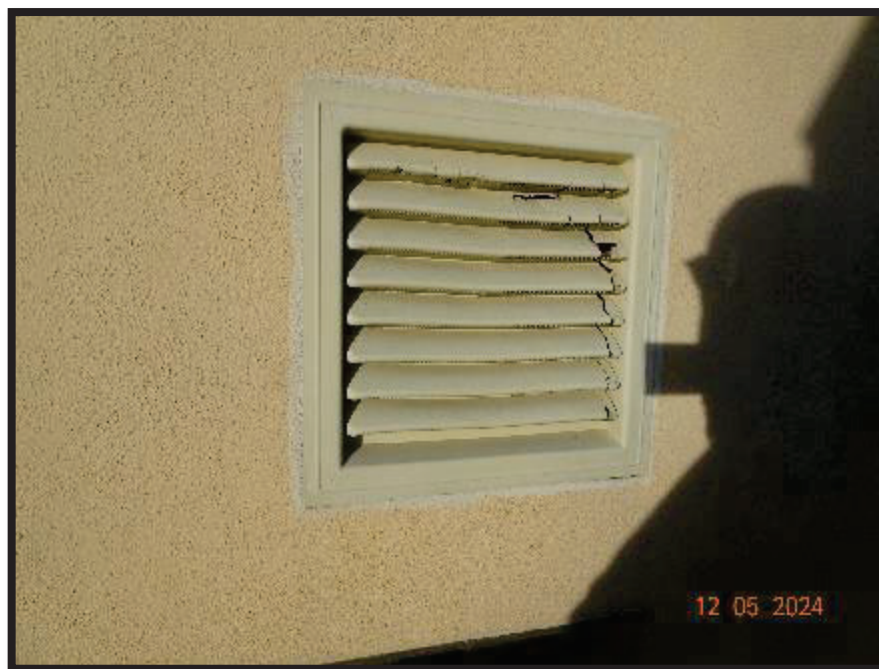
Photo 26 View of damage conditions to vinyl grill along the exterior side of the tower wall. Vinyl was observed to be brittle.

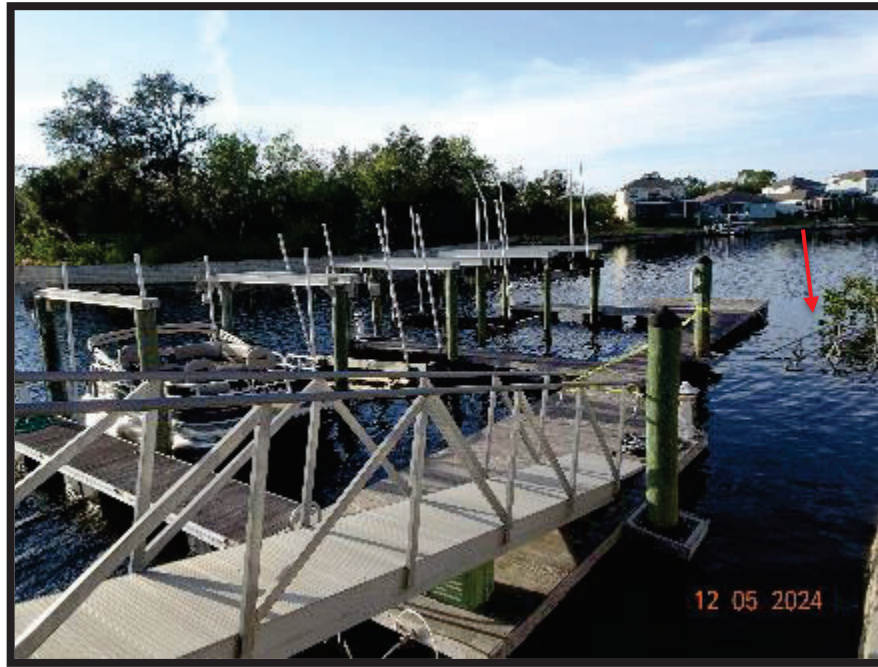
Photo 29 View of the boat lift stations along the north end of the marina. The arrow depicts the location of the guy bridge that collapsed into the water.

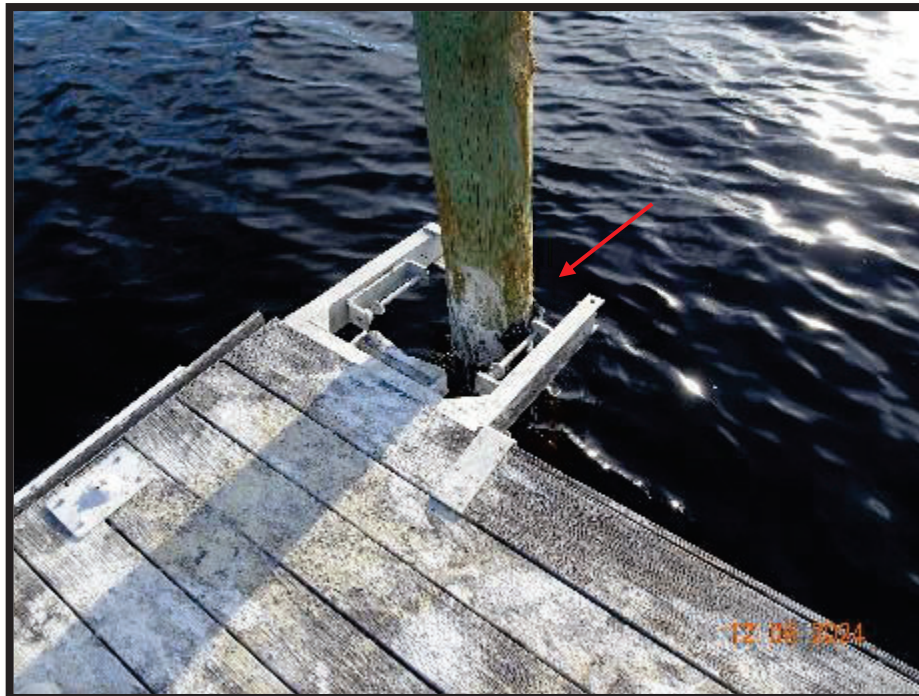
- l. The missing and bent metal components of the roller assemblies more likely than not had been exacerbated by the flooding effects as a result of the storm surge that occurred following the passage of Hurricane Helene.

Photo 30 View of missing metal channel section along one of the roller pile guides. Also, note the missing rubber rollers.

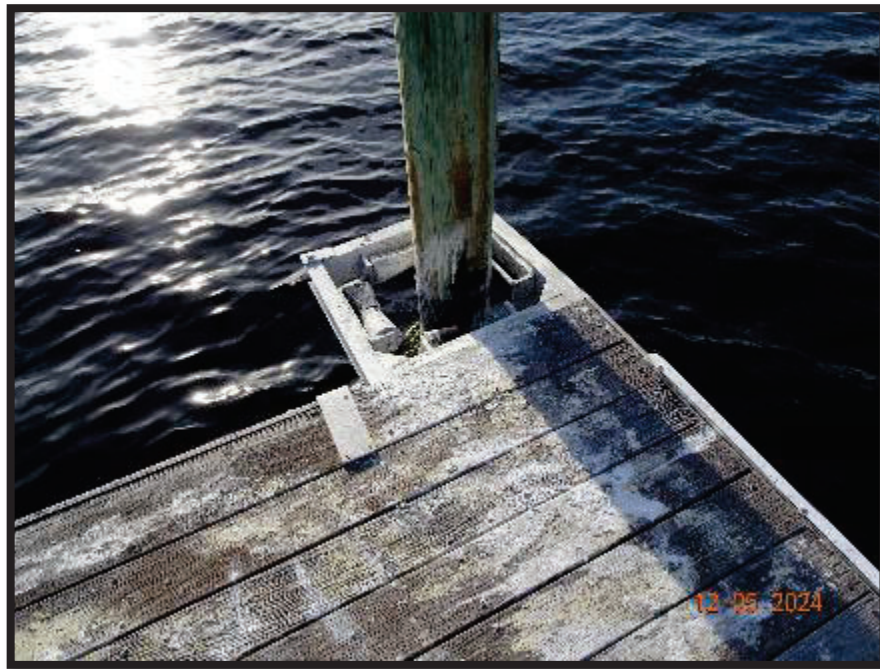
Photo 31 View of roller pile guide with one missing rubber roller. Existing rubber rollers were observed to be degraded and deteriorated.

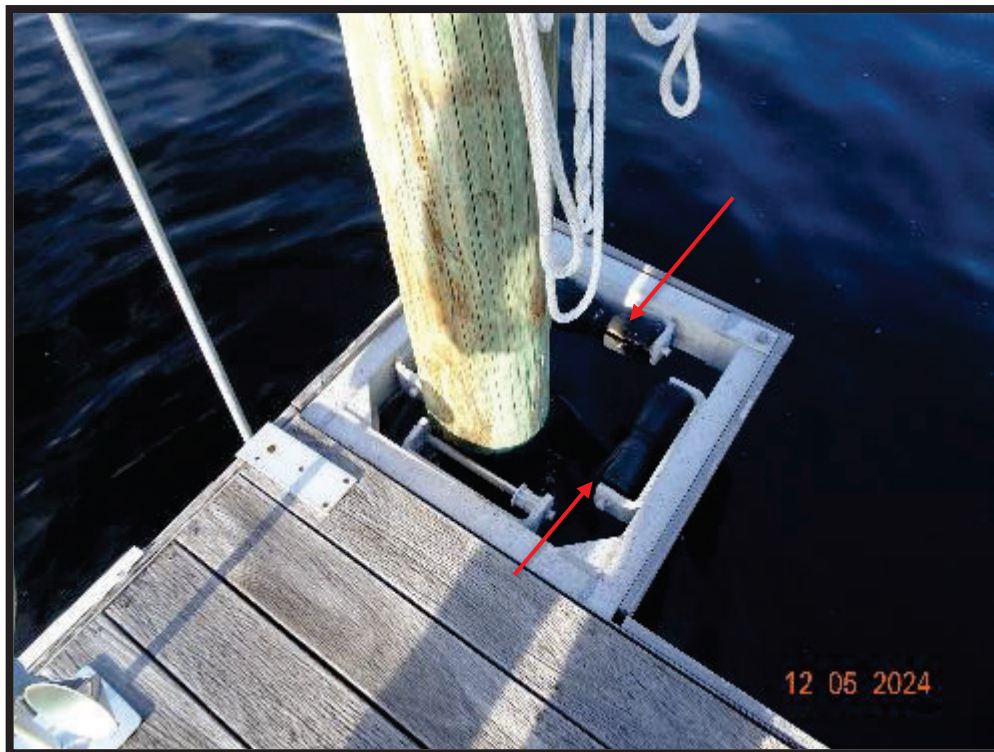
Photo 32 View of roller pile guide with two missing rubber rollers and remaining black rollers having a longitudinal crack.

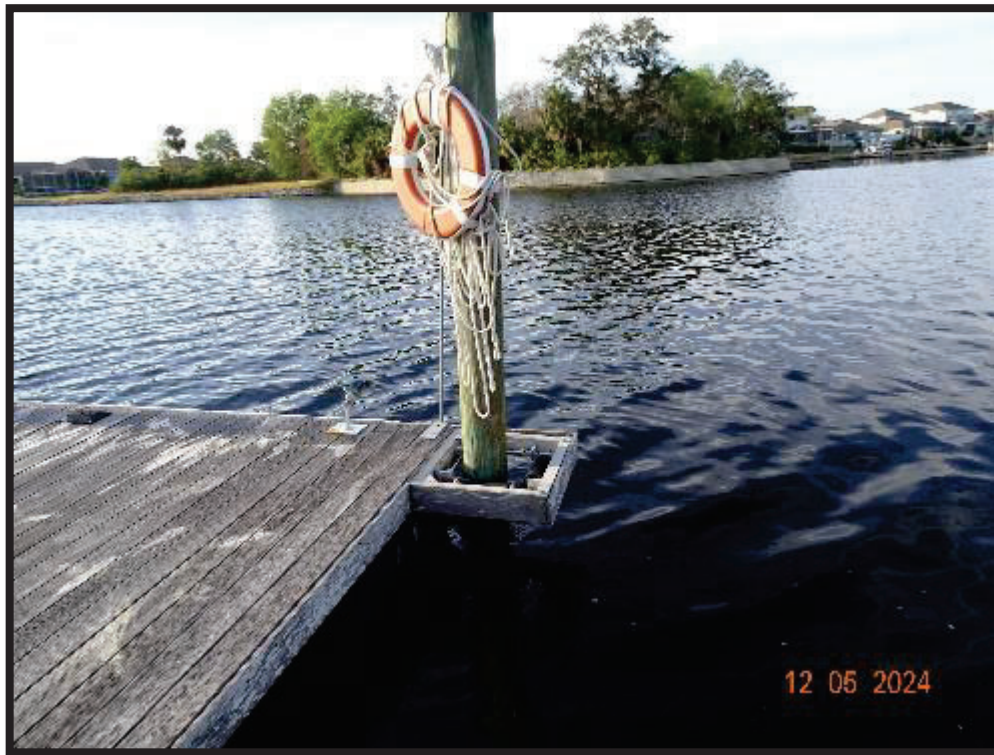
Photo 33 View of timber pile through a roller pile guide with missing rubber rollers.

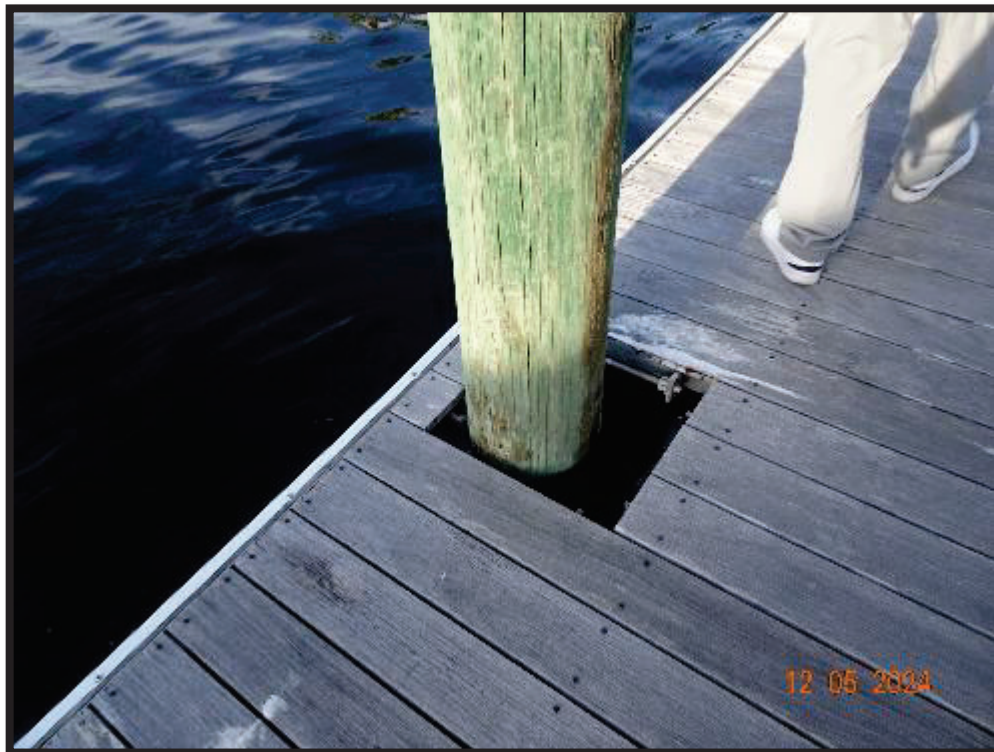
Photo 34 View of roller pile guide within the dock perimeter missing rubber rollers.

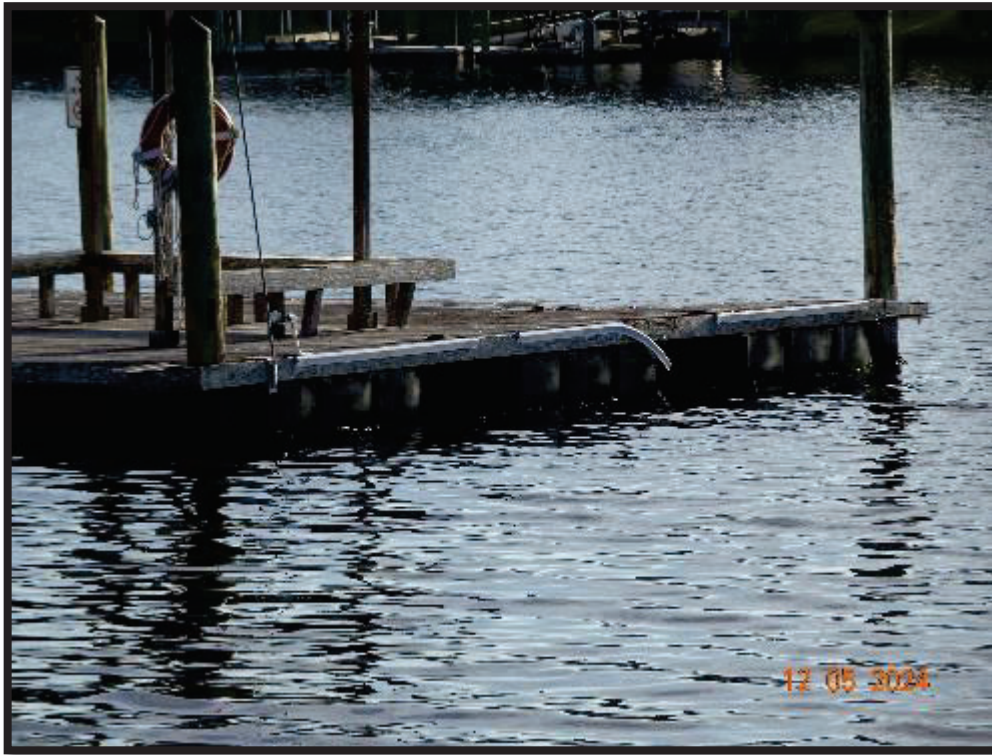
Photo 35 View of rubber bumpers loose.

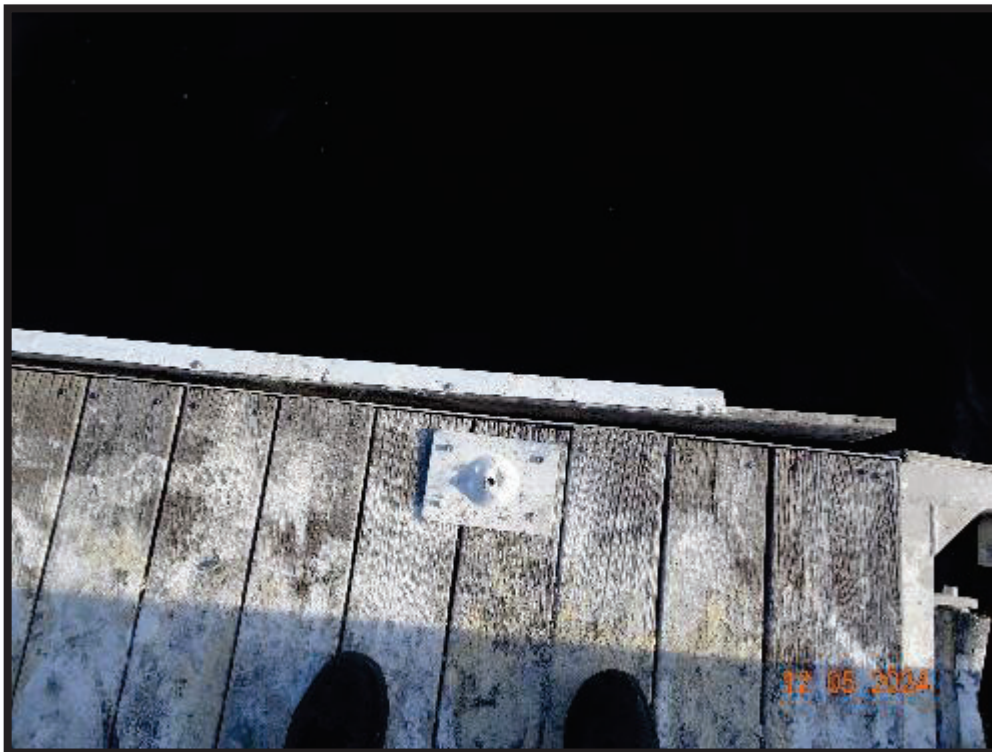
Photo 36 View of rubber bumper with fascia board observed to be loose.

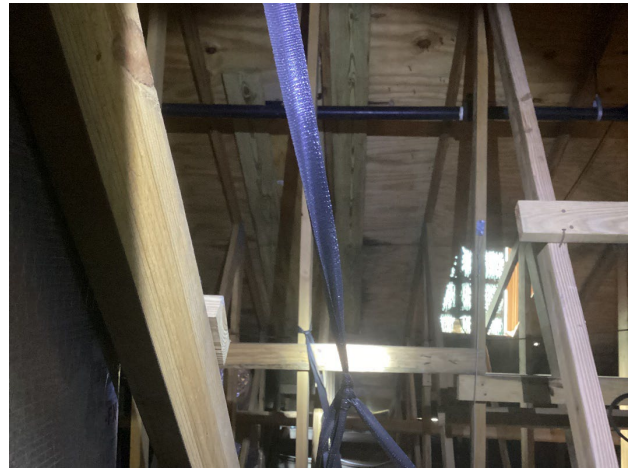
2. Attic Historic Damage (Repairs)

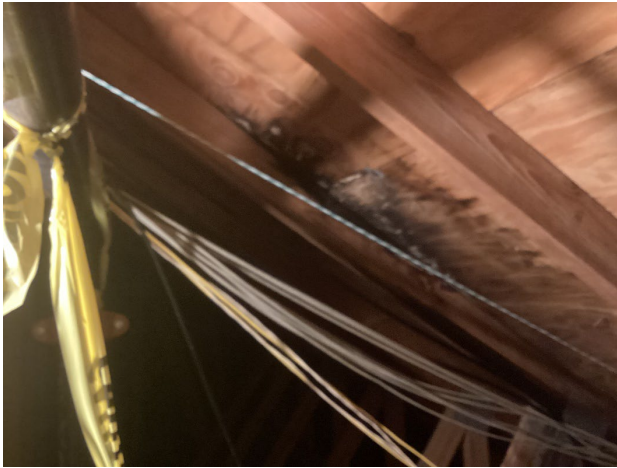
3. Attic Historic Damage

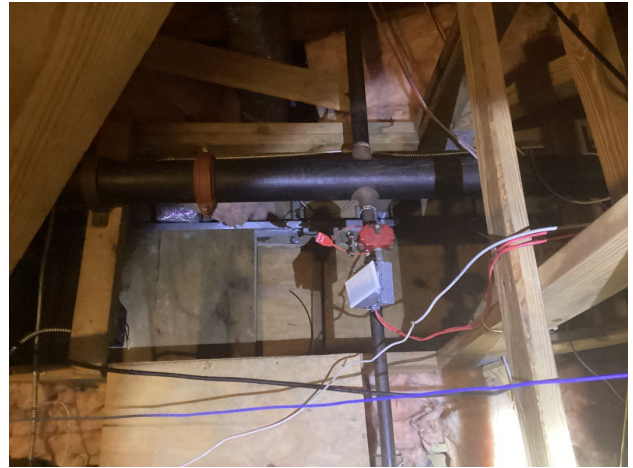
4. Attic Historic Damage

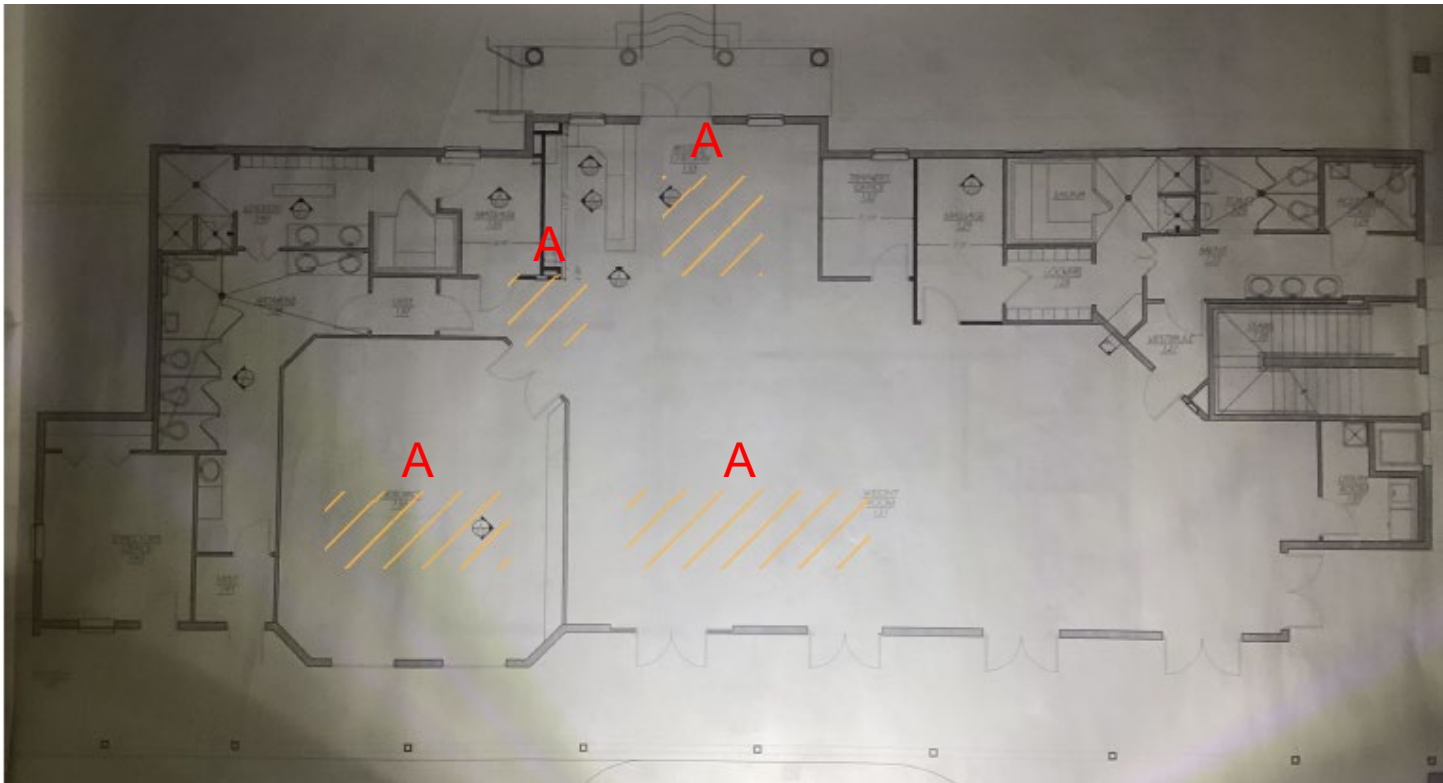
Damage Diagrams
Gym
205 Manns Harbor Drive
Apollo Beach, FL 33572

Notes:
A: Pre-existing water damage.
