Harbor Bay Community Development District  
c/o Governmental Management Services - Tampa  
4530 Eagle Falls Pl  
Tampa, FL 33619

| Cause of Loss: | Hurricane Milton |
| McLarens File: | 009.023748.MI |

McLarens, on behalf of multiple carriers, requested that Halliwell Engineering Associates (Halliwell) perform an investigation of damage associated with a named weather event, Hurricane Milton (the Event) to a Resort Property. The loss location is the Resort Property located at 107 Manns Harbor Drive, Apollo Beach, FL 33572, identified as (the Property).

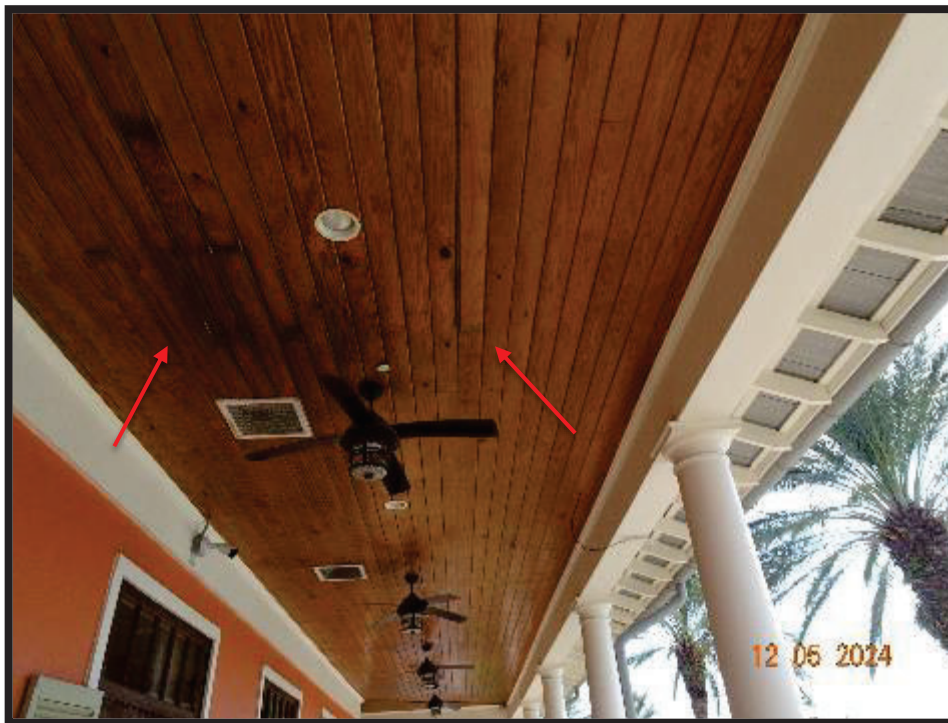
- c. The conditions observed to the ceiling wood tongue and groove planks along the rear patio canopy along the second floor of the Main Building are associated with long-term moisture conditions based on the repair work associated with the substrate conditions found above this area from the roof attic access

3. There was no access to the roof covering during Halliwell's inspection.
4. Along the exterior rear patio area along the second floor, there were several tongue and groove planks along the ceiling that were observed to have been dislodged.

7. There was visible evidence of past repairs performed to the ceiling areas above the rear canopy area where the tongue and groove planks were observed to have moisture damage conditions accessed and observed through the attic space of the upper roof level catwalks.

**Photo 2** View of the rear patio canopy along the second floor depicting damage conditions to the wood tongue and groove planks along the ceiling.

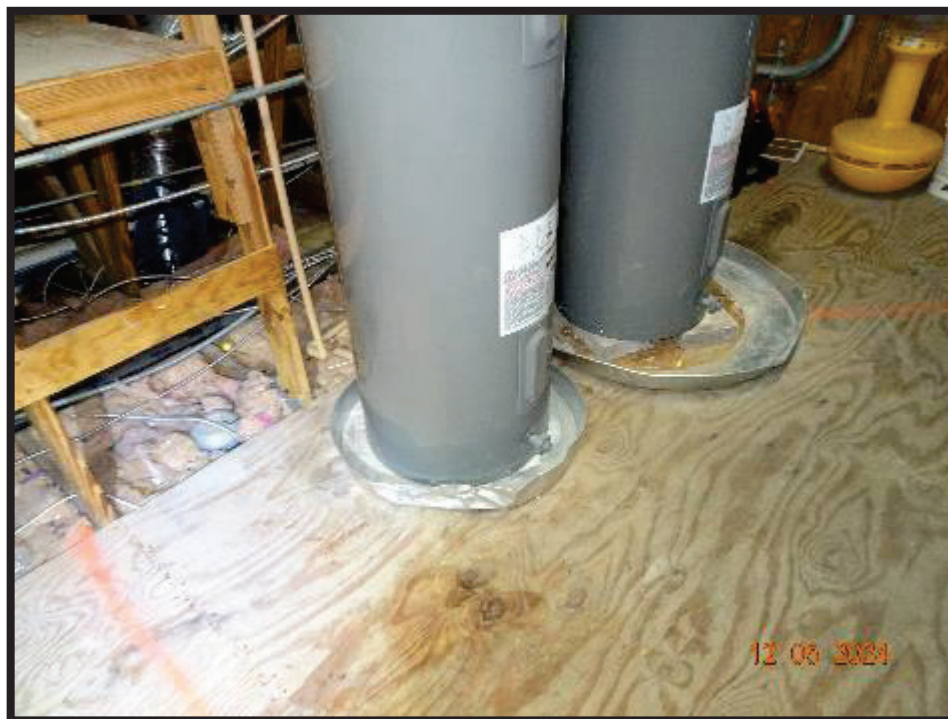
**Photo 6** View of drain pans along the bottom of water tanks in the Mezzanine area. Note drain pans do not have an overflow pipe.

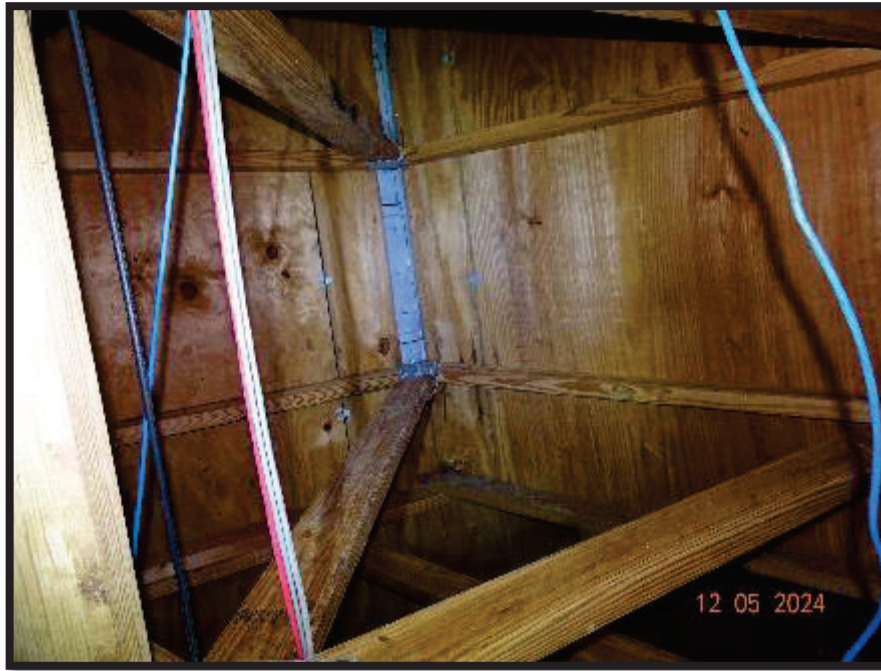
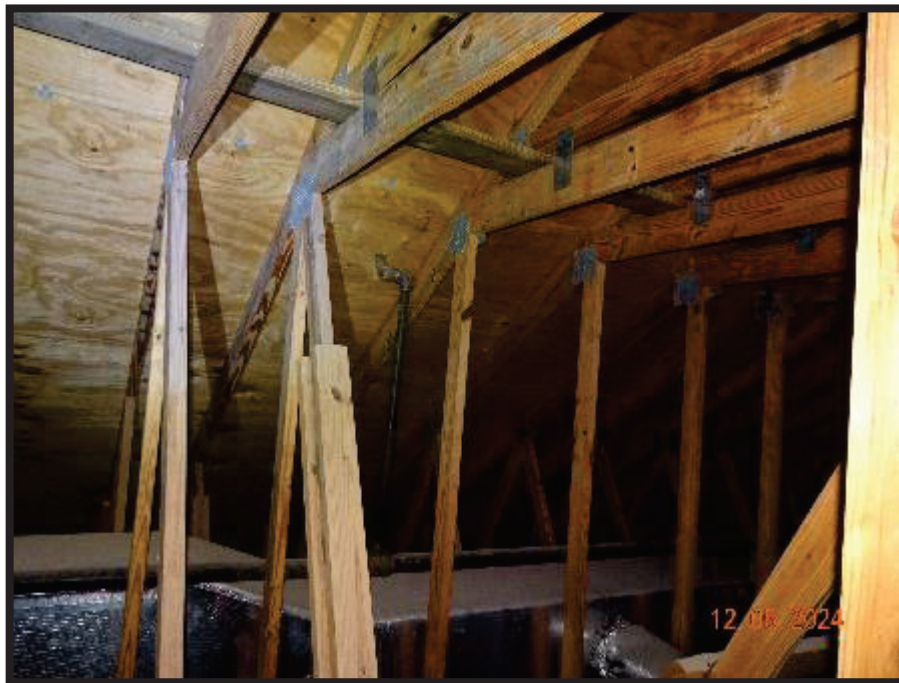
8. There was no visibly apparent evidence of moisture stains along the underside plywood sheathing at the roof trusses above the mezzanine/fitness area.

**Photo 7** View of wood truss framing within the Mezzanine area. No visibly apparent evidence of water stains on the underside of the plywood sheathing to suggest moisture intrusion from the roof.

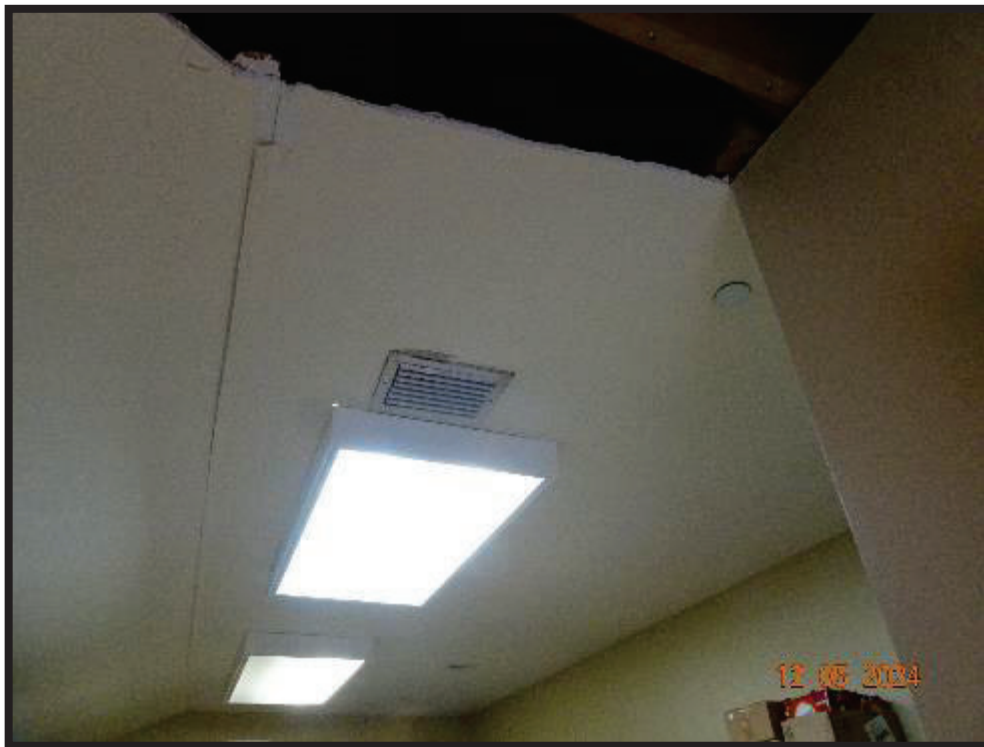
**Photo 12** View of stain along ceiling diffuser along the ceiling at the entrance to the Mezzanine area.

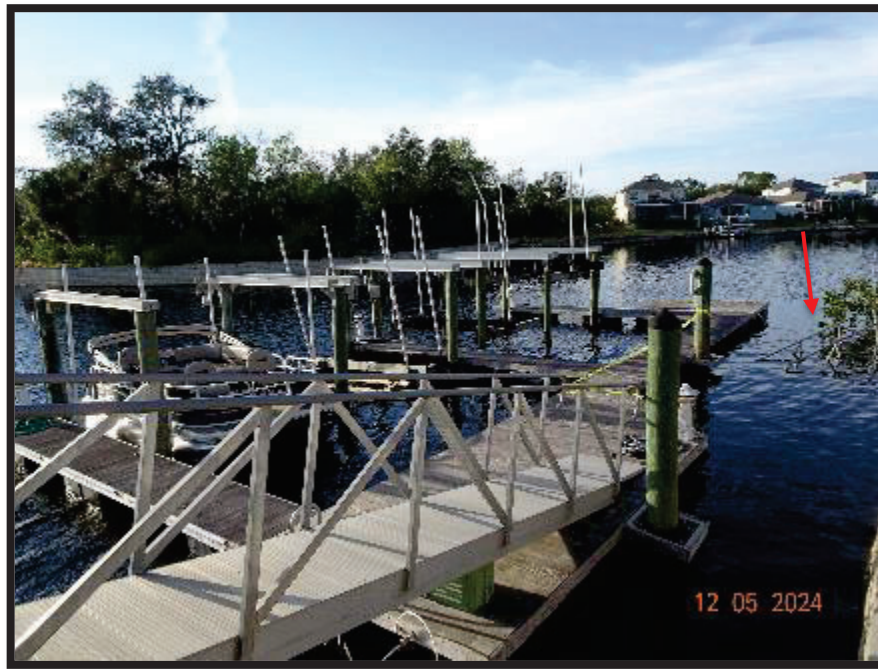
**Photo 29** View of the boat lift stations along the north end of the marina. The arrow depicts the location of the guy bridge that collapsed into the water.

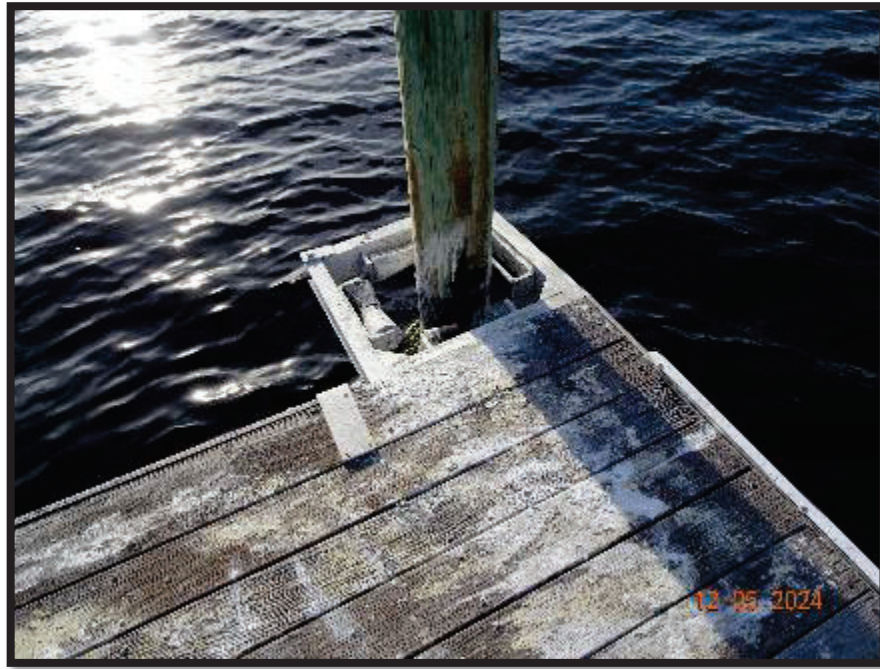
**Photo 31** View of roller pile guide with one missing rubber roller. Existing rubber rollers were observed to be degraded and deteriorated.

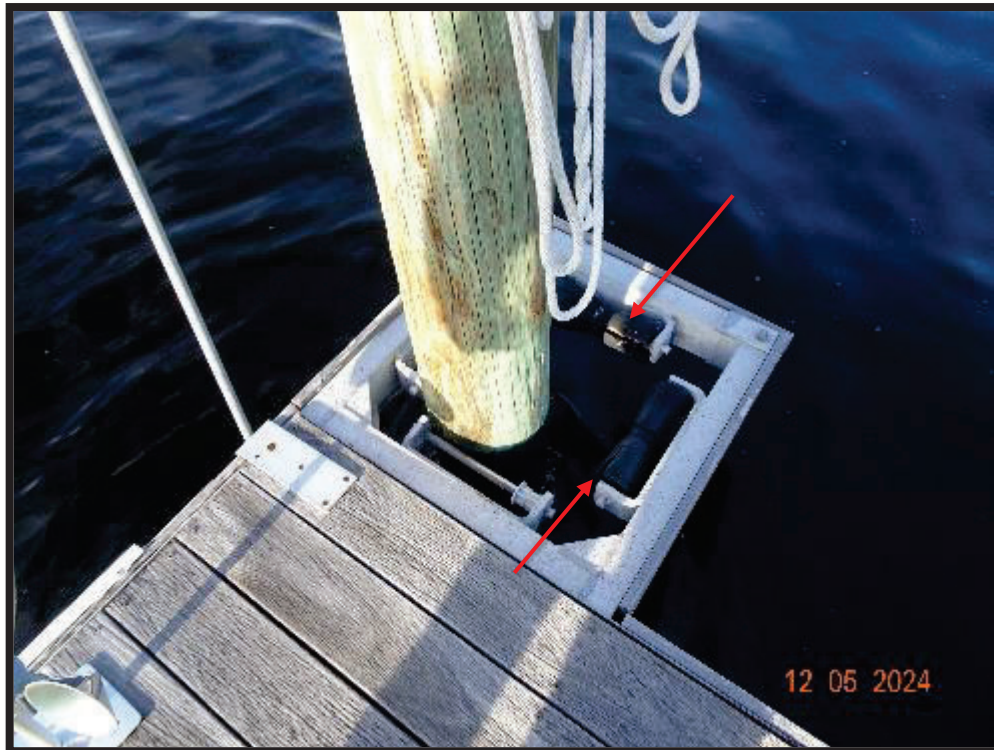
**Photo 32** View of roller pile guide with two missing rubber rollers and remaining black rollers having a longitudinal crack.

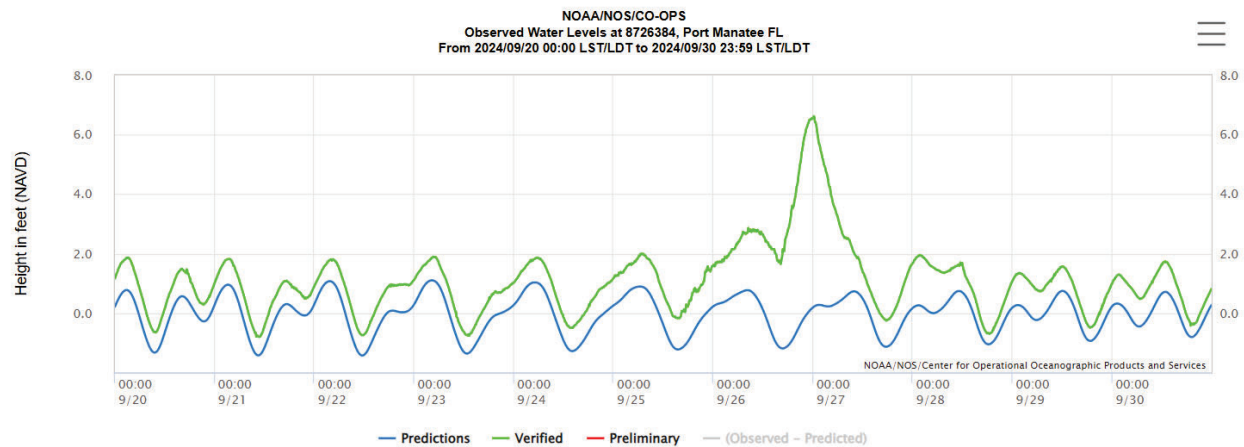
**Figure 2:** Elevation of Tampa Bay at NOAA gage 8726384, Port Manatee, Florida, around the impact of Hurricane Helene. The peak elevation of the gage was 6.62 feet NAVD88, at 12:12 AM EDT, September 27, 2024.

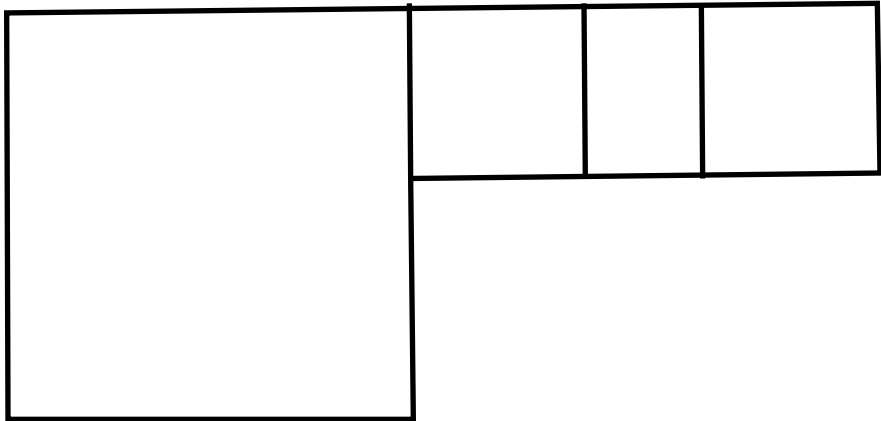
Damage Diagrams  
**The Docking Club**  
205 Manns Harbor Drive  
Apollo Beach, FL 33572

No Damage Noted.
