DEPARTMENT OF BUSINESS AND  
PROFESSIONAL REGULATION

I am having some serious doubts regarding the validity and completeness of the information that is being presented to me by our engineering consultant, Mr. John Magnavita from Langan Engineering, and I am extremely concerned. Given that our board decisions are being based almost entirely on Mr. Magnavita and Langan's professional recommendations, any technical errors or failures in sound engineering judgement may have disastrous and potentially dangerous results in my opinion. He has in the past made contradictory statements regarding the longterm viability of his design and I have been met with defensive posturing when attempting to challenge him on key aspects. It has gotten so bad that I have taken the step of issuing a no confidence statement related to his engineering work on our project.

By way of background, our community is a canal community off of Tampa Bay and contains approximately 7 miles of bulkhead which is currently in a state of failure. Upland damages to residents homes have been occurring and continue to occur at an ever worsening rate. Two stabilization options are being recommended by Mr. Magnavita and his e

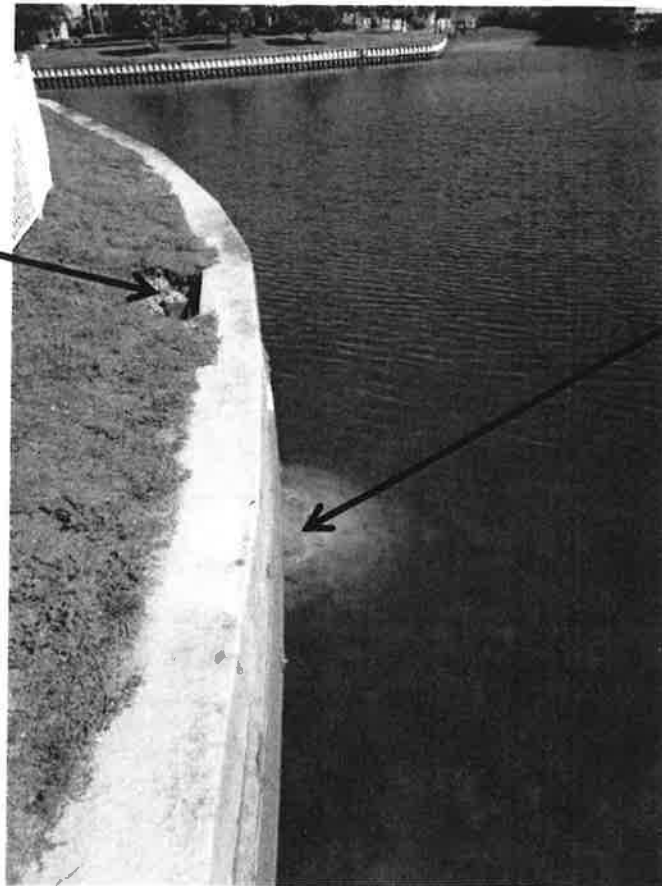
## SHALLOW SHEET PILE CONDITION – 5617 SEAGRASS PLACE

Landside Soil  
Depression as deep as  
Approx. EL -1  
Immediately Landside  
of Sheet Pile

Soil accumulation as  
deep as Approx.  
EL -1.5 to EL +1  
Immediately  
Waterside of Sheet  
Pile

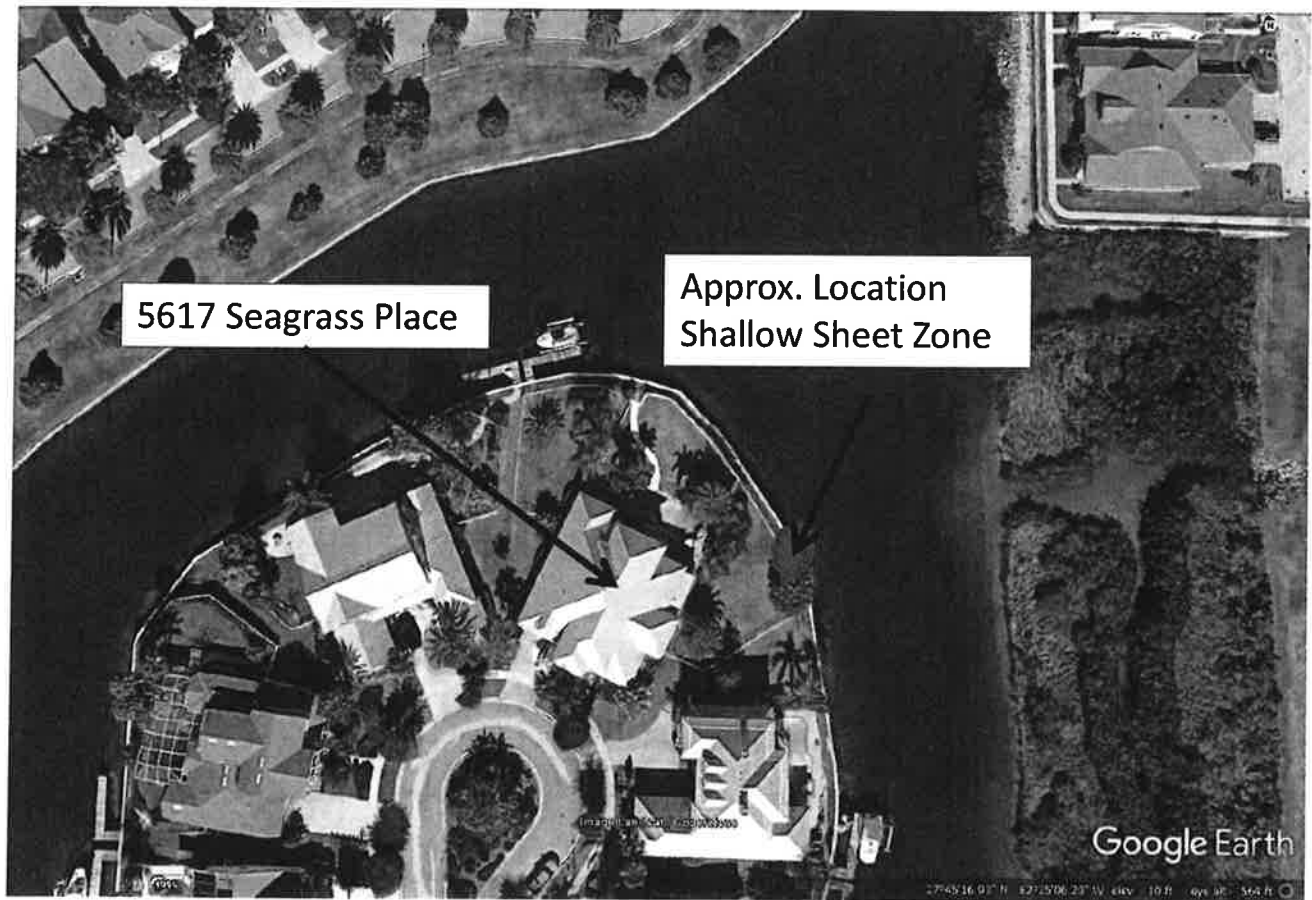
## SHALLOW SHEET PILE CONDITION – PHOTOGRAPHS

**Bulkhead Length is Approx. 200 Linear Feet, Shallow Sheet Zone is Approx. 4 ft long**

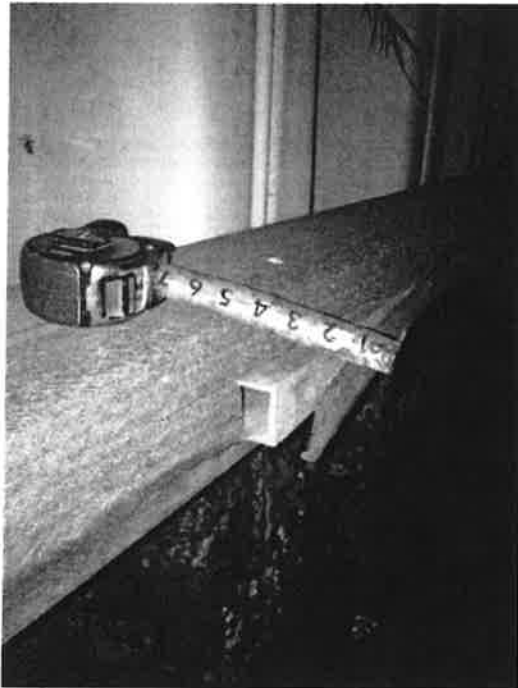
Overstressed/Damaged Waler

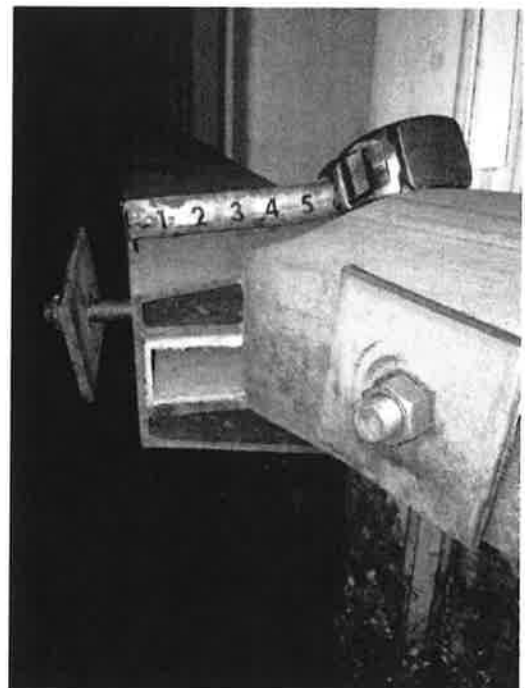
Over Stressed Anchor Connection

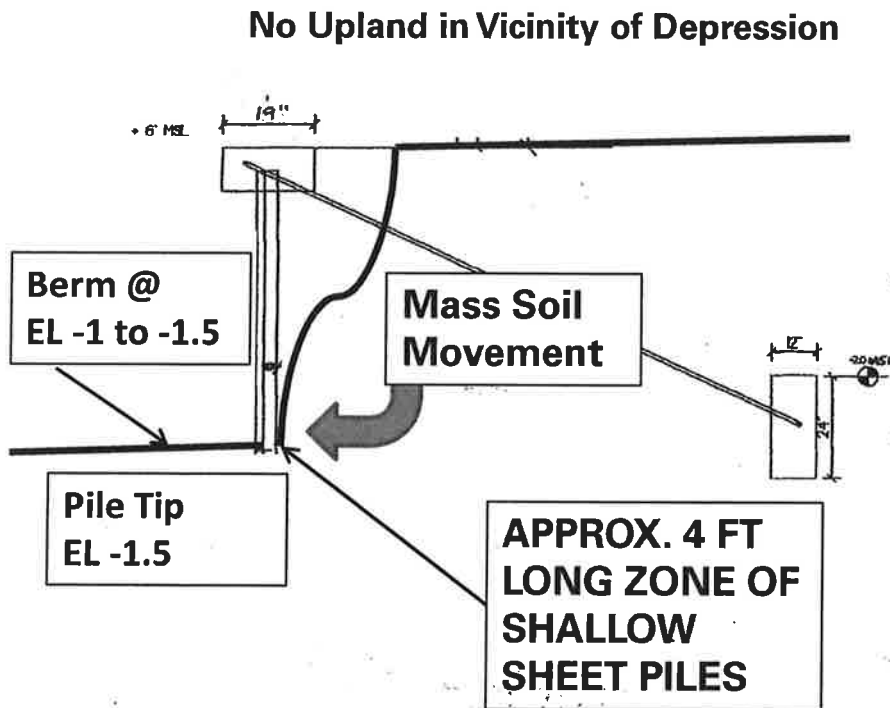
# EXISTING CONDITIONS AT 5617 SEAGRASS PLACE

- WATERSIDE BERM LOWERED FROM CONSTRUCTED 5 FT WIDE BENCH AT EL +1 TO RELATIVELY FLAT SLOPE AT EL -1 TO -1.5
- SHEET PILE TIP IN SUBJECT ZONE IS AT EXISTING BERM LEVEL
- SOIL MOVEMENT BELOW BOTTOM OF SHEET PILES (4 FT LONG ZONE)

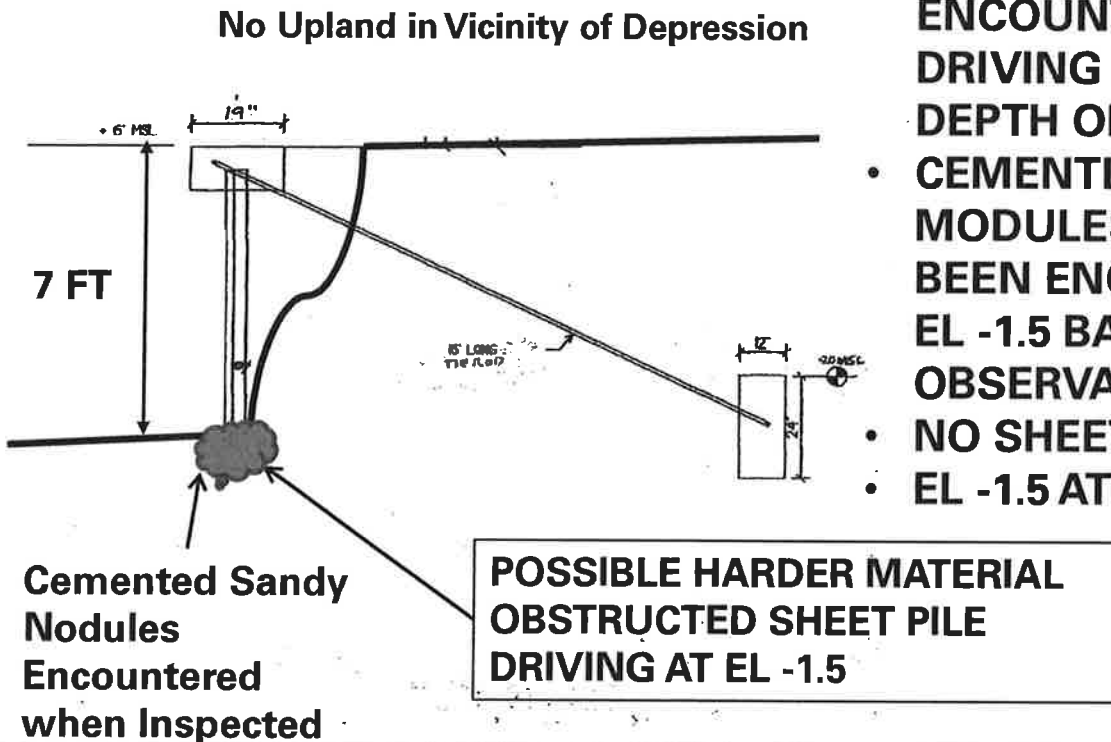
## ORIGINAL SHEET PILE DRIVING AT 5617 SEAGRASS PLACE

- IN GENERAL, RELATIVELY LOOSE MATERIAL SHOULD HAVE BEEN ENCOUNTERED WHEN DRIVING SHEET TO A DEPTH OF 6 FT
- CEMENTED SANDY MODULES MAY HAVE BEEN ENCOUNTERED AT EL -1.5 BASED ON FIELD OBSERVATION
- NO SHEET PILE BELOW EL -1.5 AT THIS LOCATION

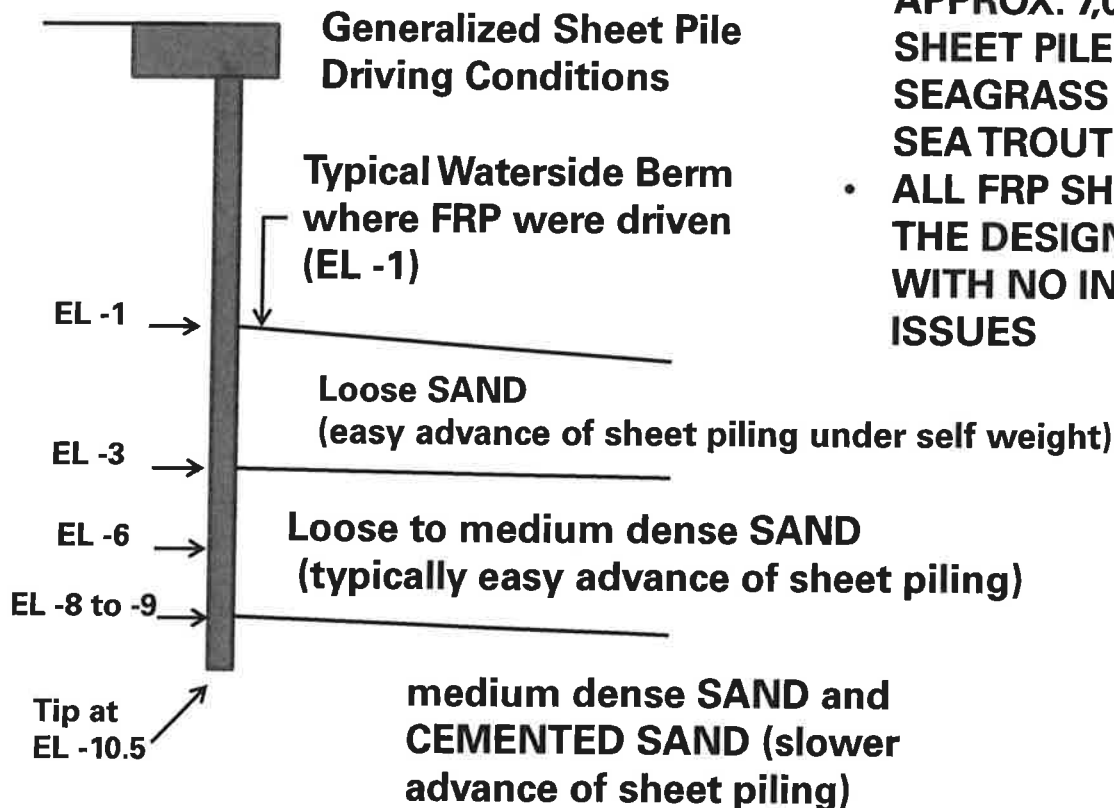
## NEARBY FRP (NEW WALL) SHEET PILE DRIVING RECORDS

- FRP DRIVING RECORDS FOR APPROX. 7,000 LINEAR FT OF SHEET PILES DRIVEN FROM SEAGRASS PLACE THROUGH SEATROUT PLACE
- ALL FRP SHEETS REACHED THE DESIGN DEPTH OF EL -10 WITH NO INSTALLATION ISSUES
