Insured:	Harbor Bay Community Development District
Insurer:	Florida Insurance Alliance
Policy Number:	100124618
Policy Term:	October 01, 2024 – October 01, 2025
Date of Loss	October 09, 2024
Cause of Loss:	Hurricane Milton
Loss Location:	Multiple (Per Property Schedule)
McLarens File:	009.023748.MI

McLarens File 009.023748.MI
Harbor Bay CDD

IX. CONCLUSIONS AND OPINIONS

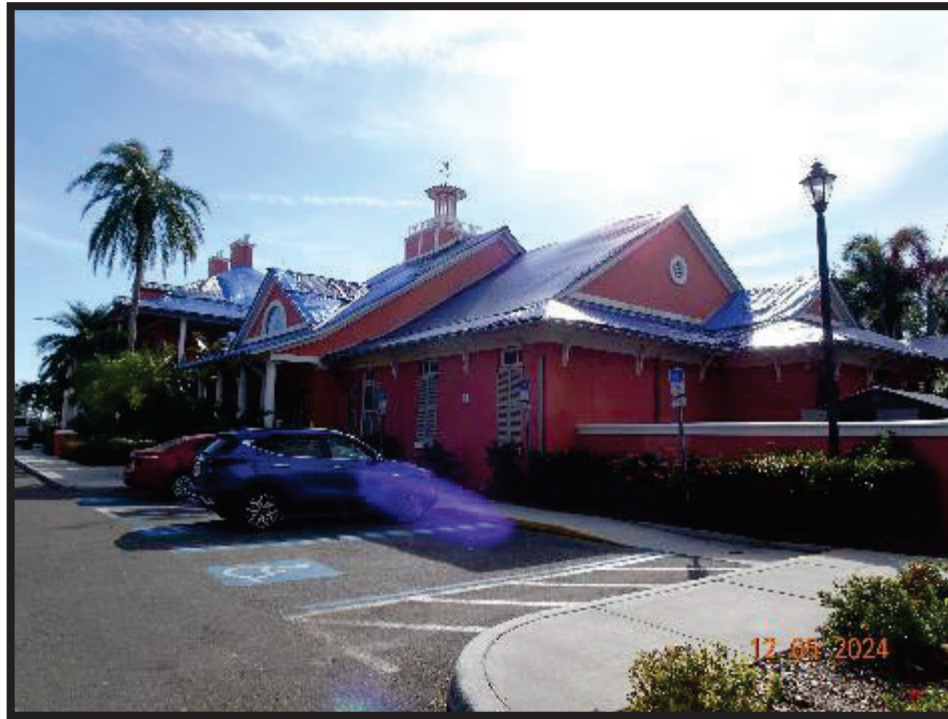
Photo 1 View of the Main building at the subject property.

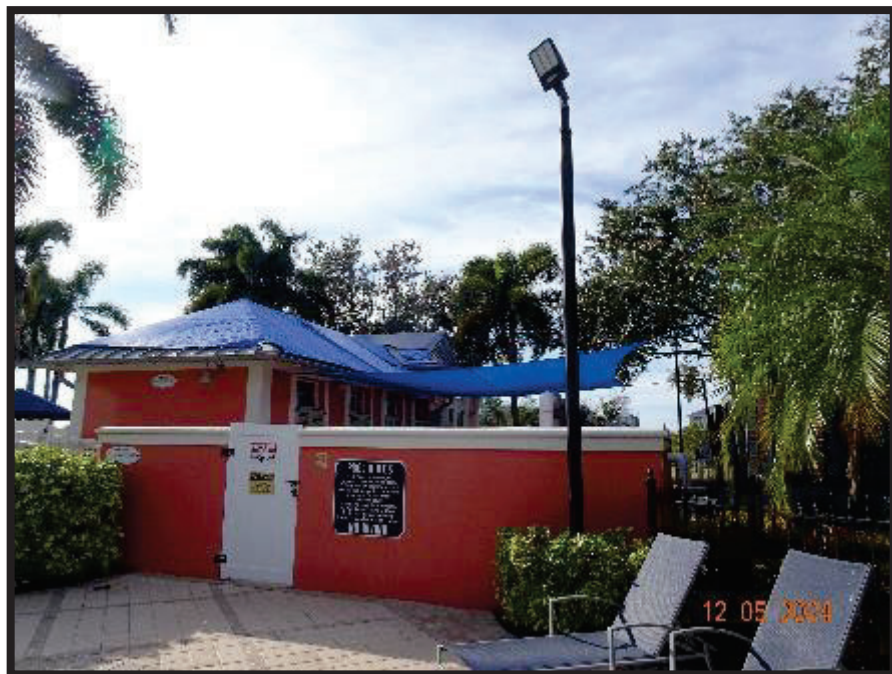
Photo 18 View of the south side elevation of the Dockers Building.

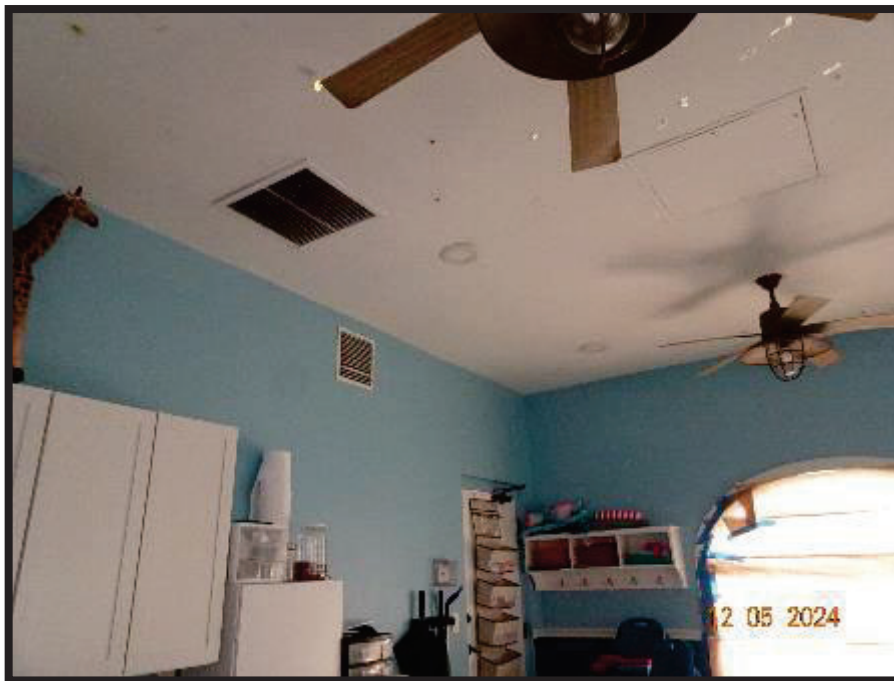
Photo 20 Additional view of ceiling area in the Dockers Building.

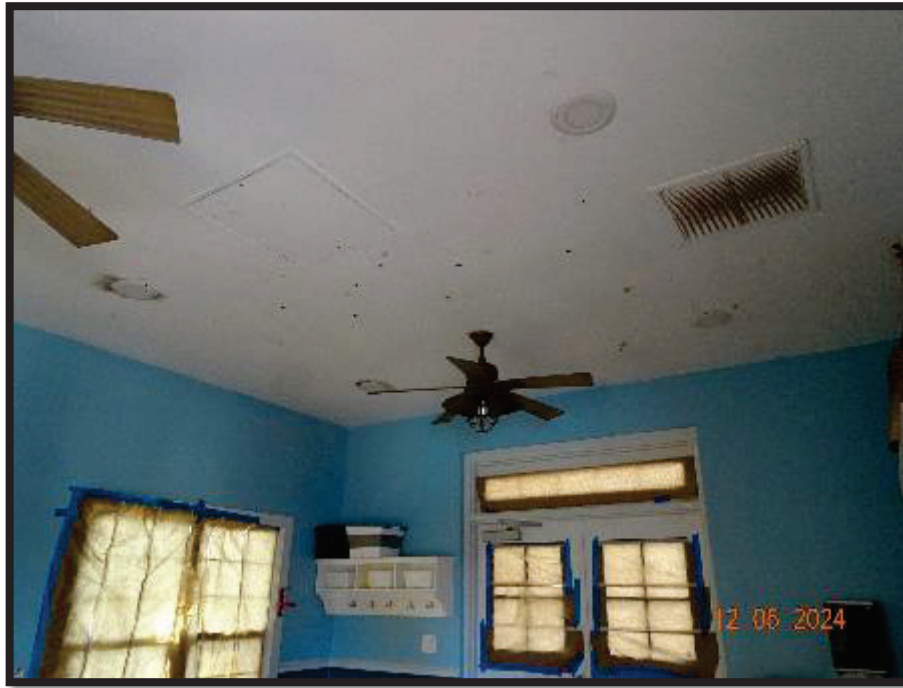
Photo 21 Additional view of the ceiling area in the Dockers Building.

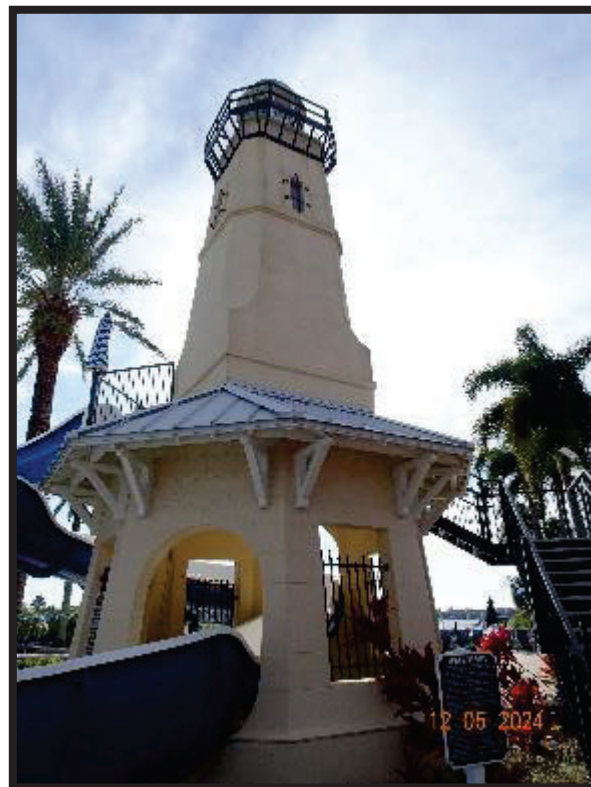
Photo 22 View of the lighthouse tower structure.

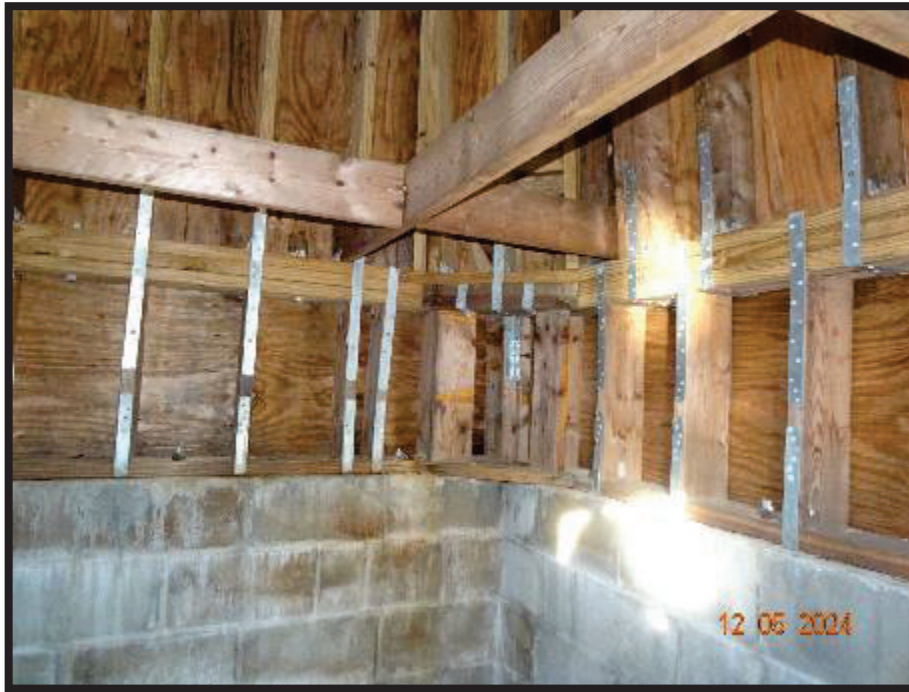
Photo 23 View of wood framed wall with concrete masonry unit blocks below.

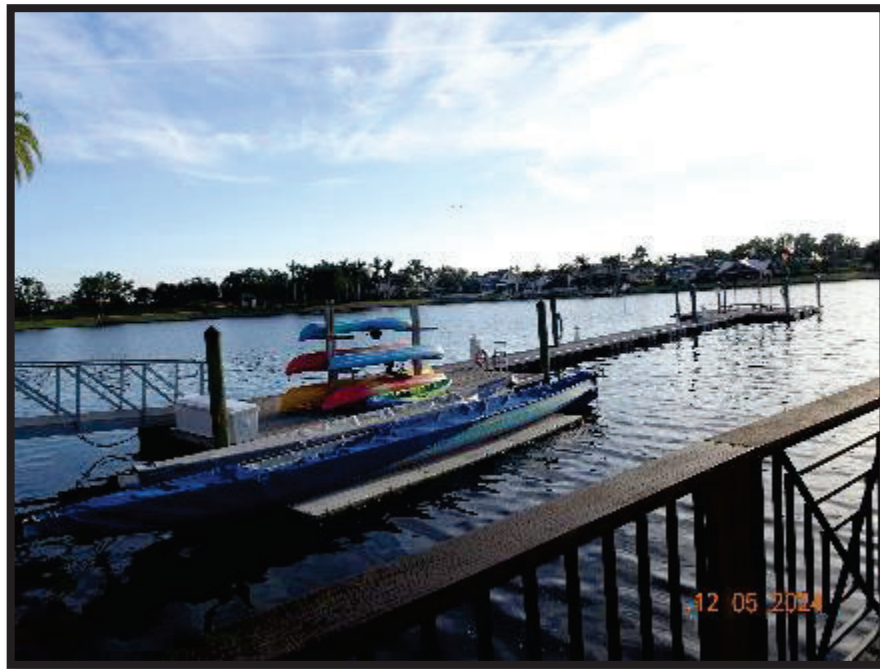
Photo 27 View of the floating dock system along the south end of the marina.

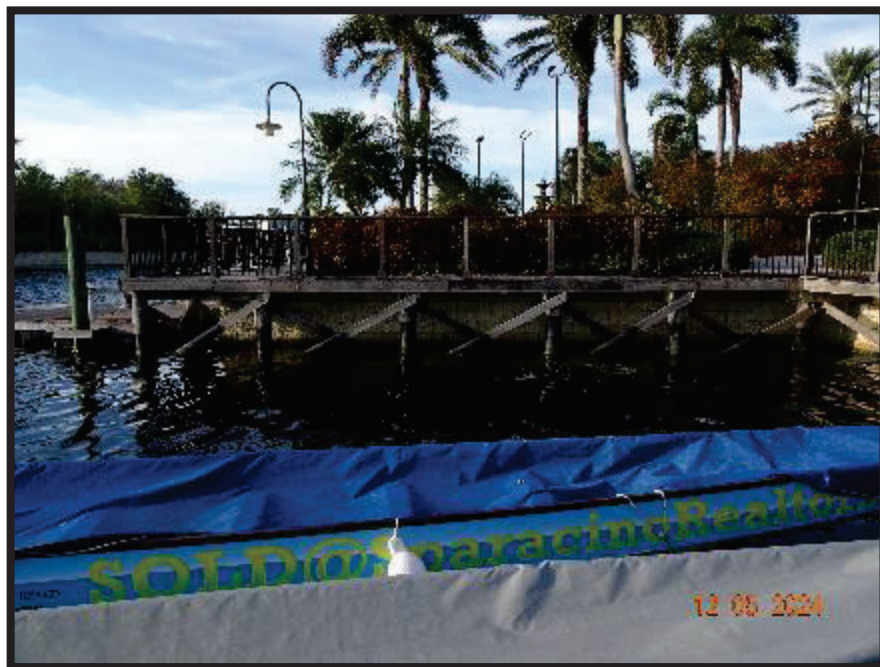
Photo 28 View of fixed dock systems along the north end of the marina.

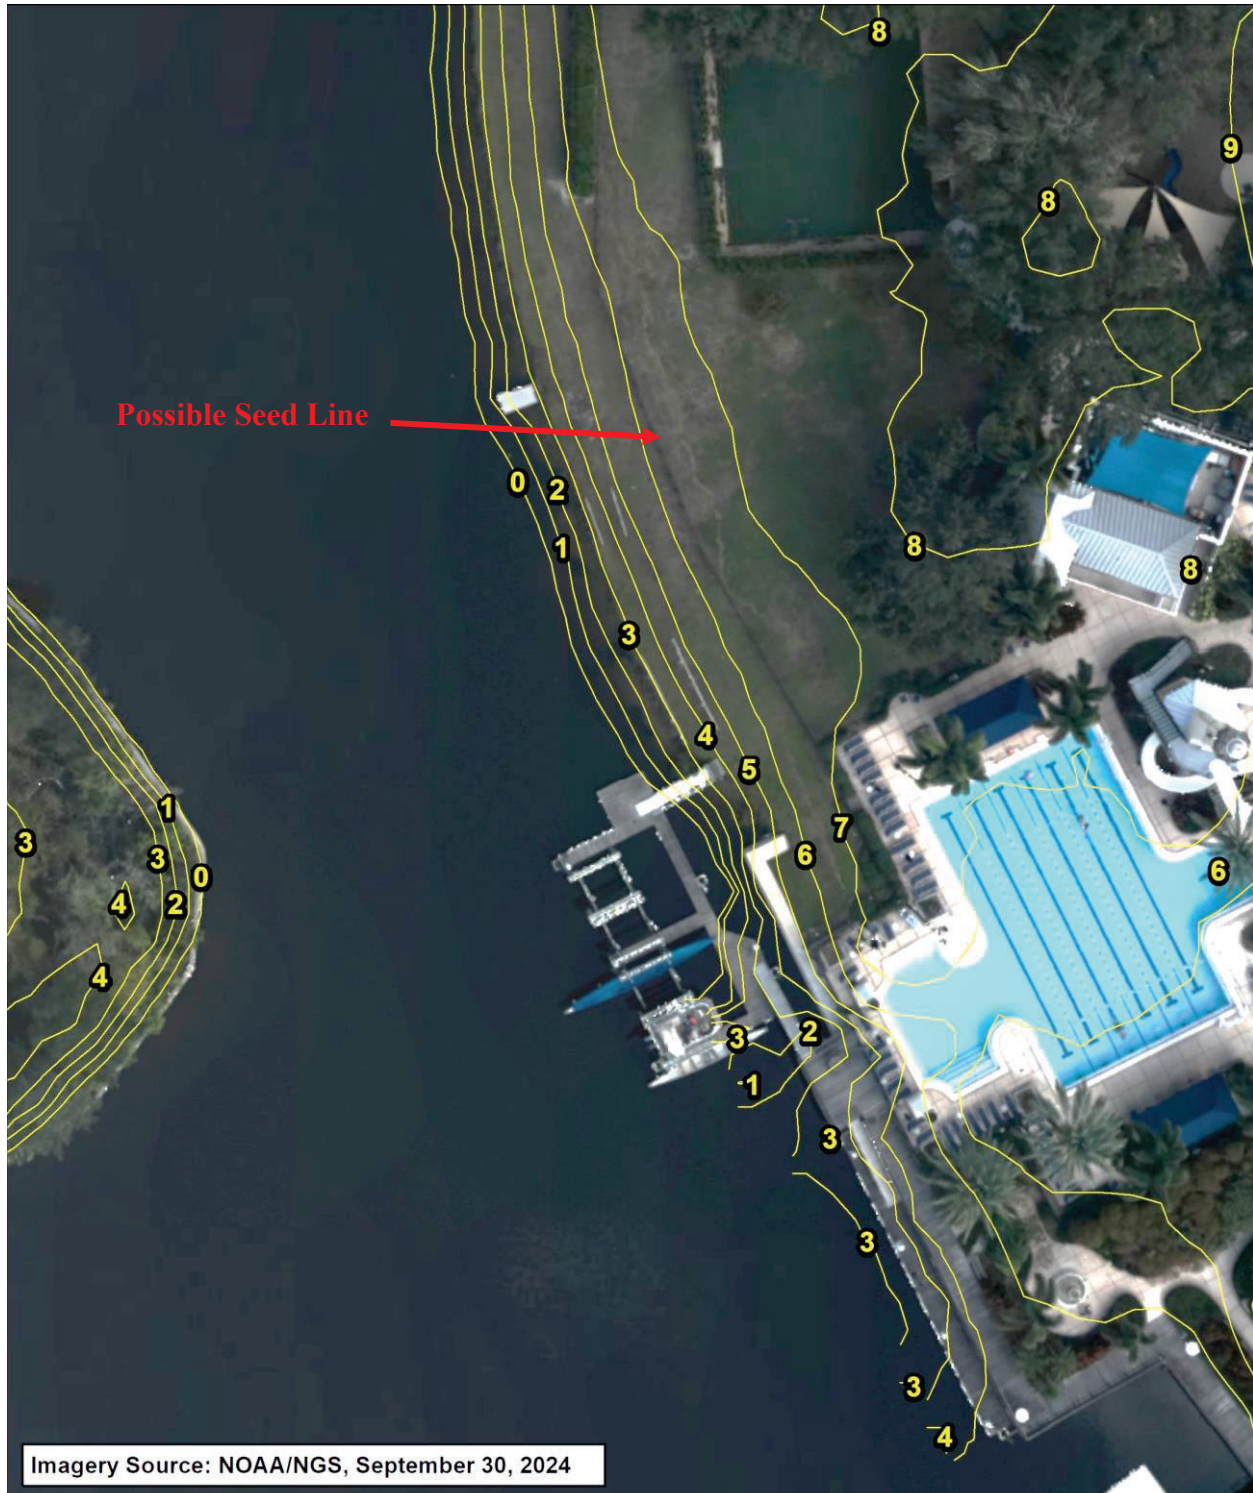
Halliwell researched the grade elevation of the subject property and found the elevation of a possible seed line (debris remaining after the water recedes), between 6 and 7 feet NAVD88 (see Figure 3 in

Figure 3: NOAA/NGS LIDAR-derived elevation contours in the vicinity of the subject property, overlaid on post-storm NOAA/NGS imagery, dated September 30, 2024.

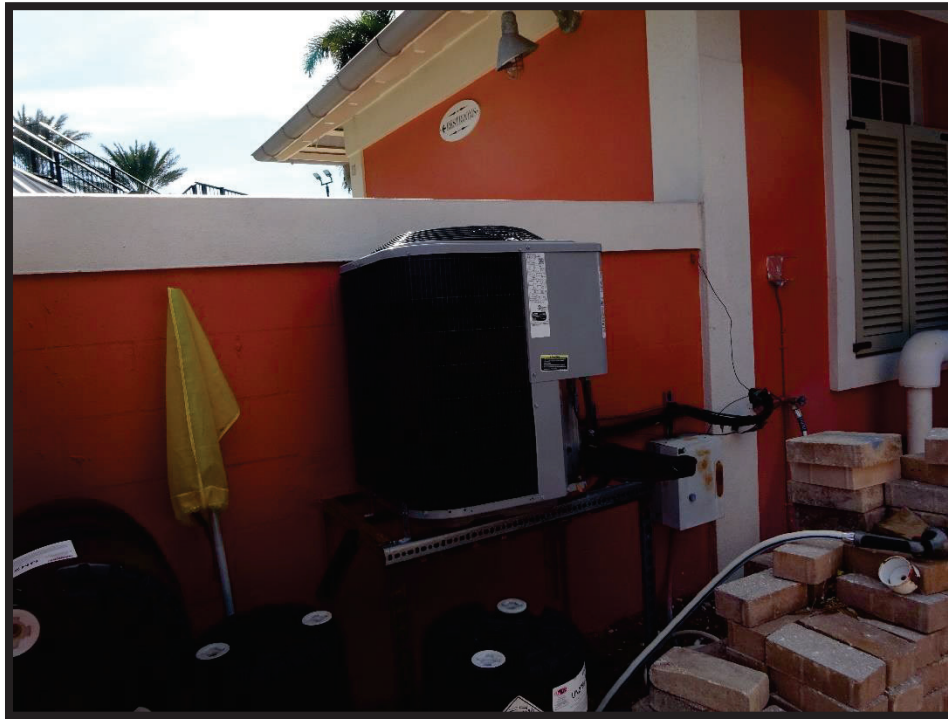
Photo 1 Typical frame-mounted condensing unit.

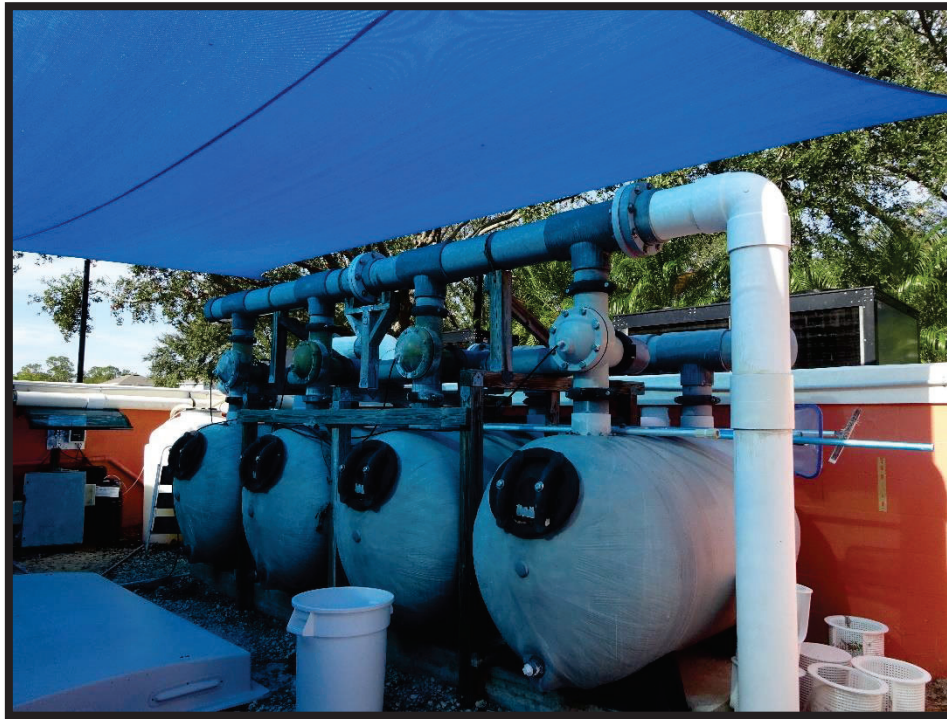
Photo 3 Typical floor-mounted horizontal sand filter.

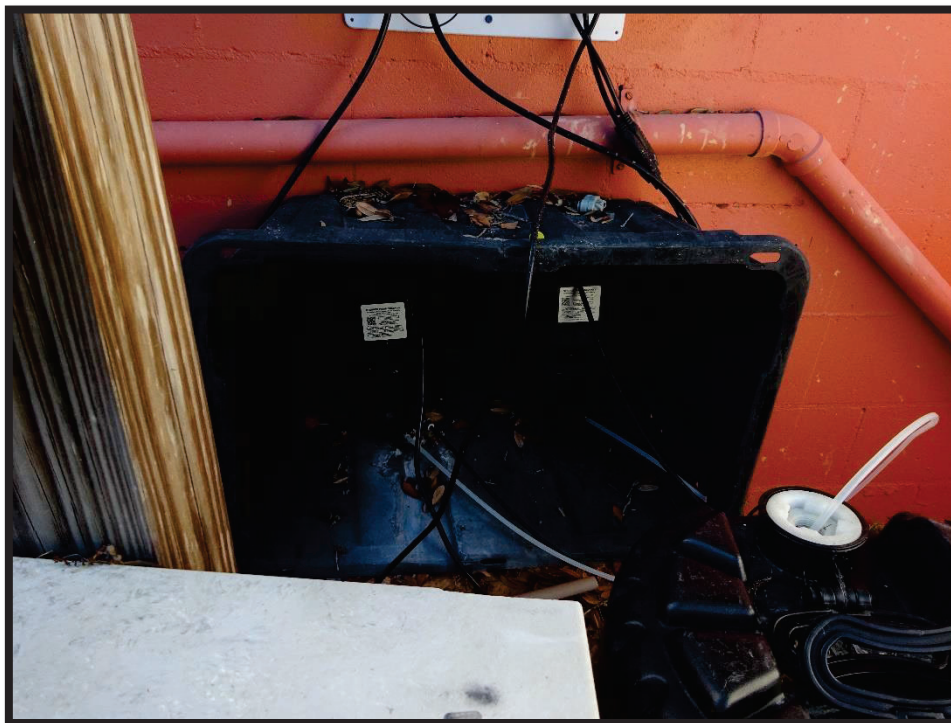
Photo 4 Chemical metering pumps.

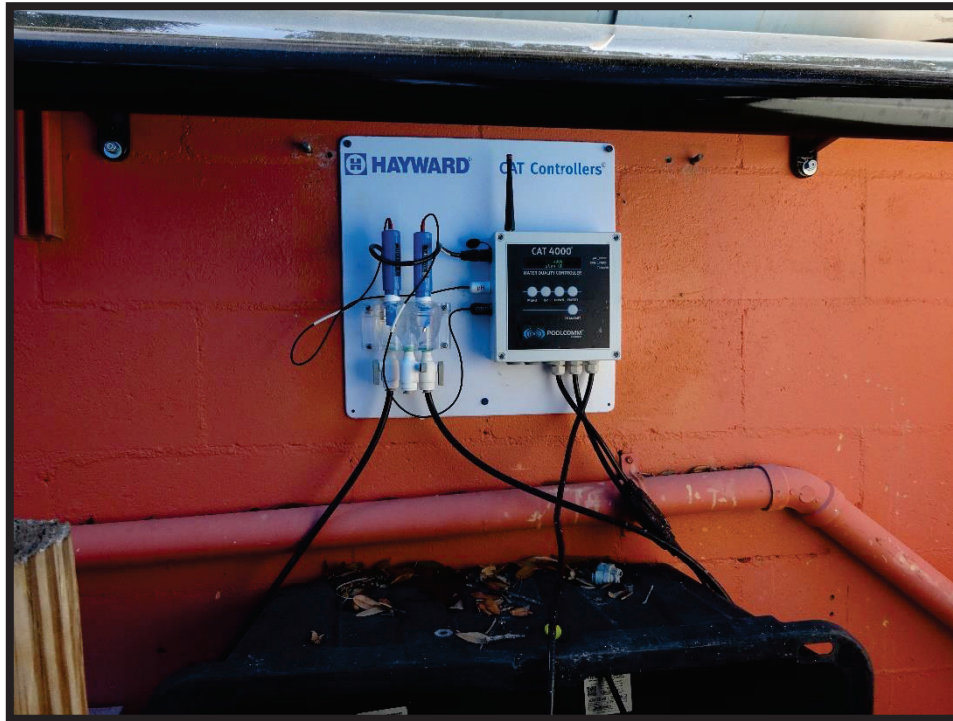
Photo 5 Wall-mounted water quality controller.

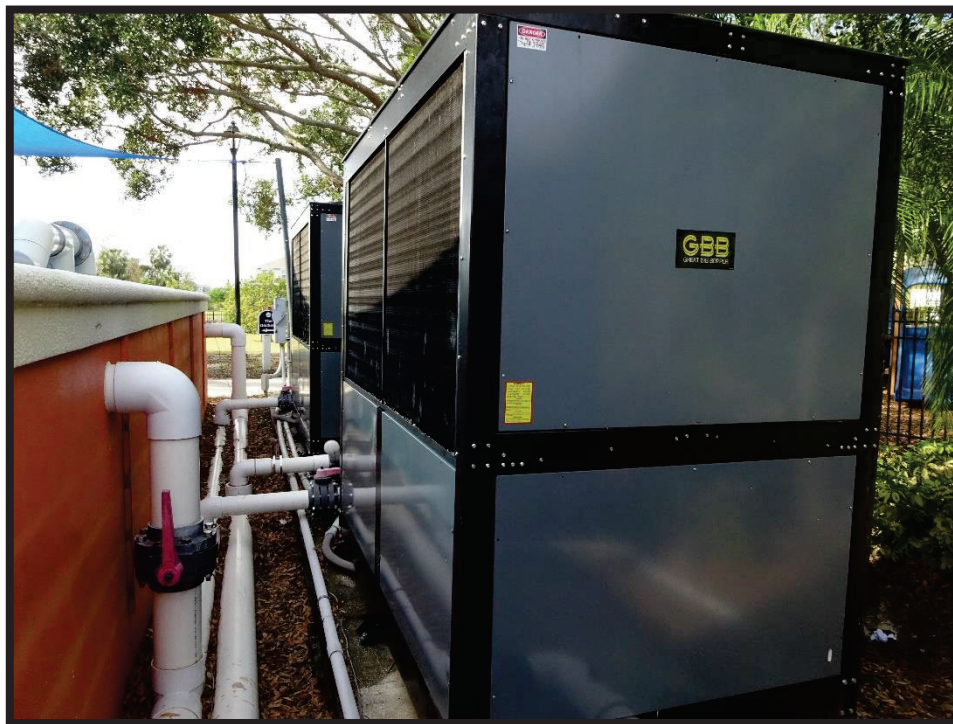
Photo 6 Typical pool heat pump heater/cooler.

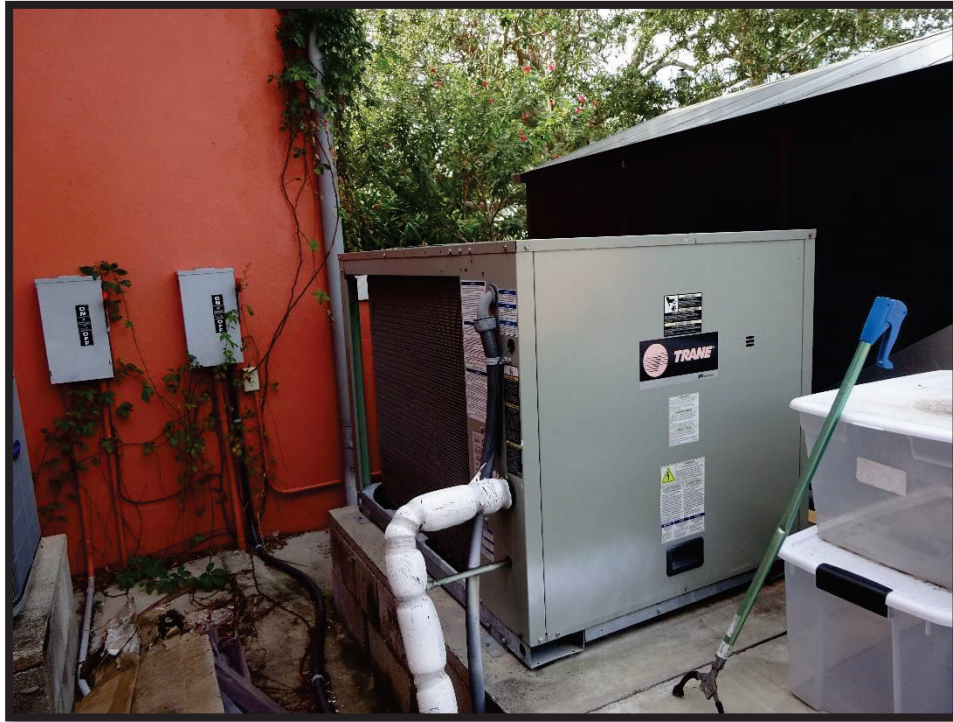
Photo 7 Typical floor-mounted condensing unit.

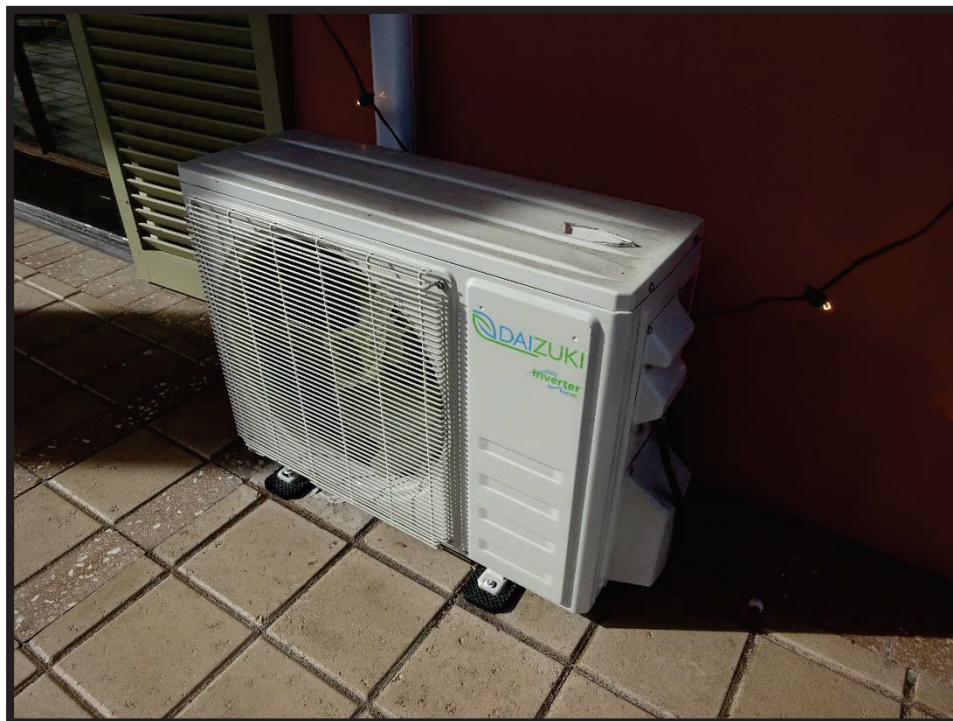
Photo 8 Typical floor-mounted mini split condensing unit.

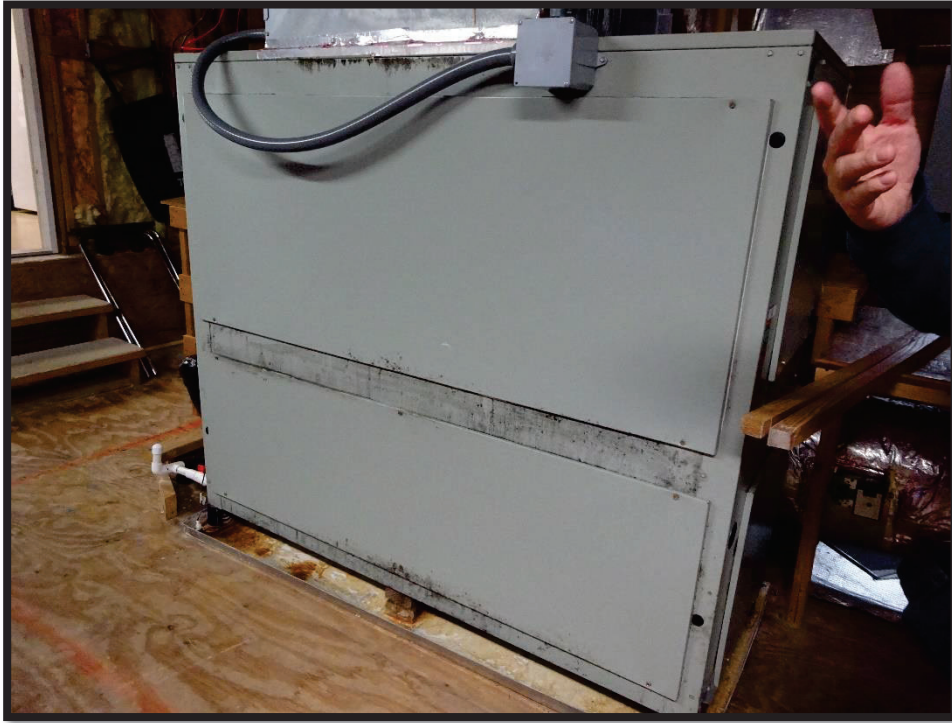
Photo 9 Typical interior horizontal air handling unit.

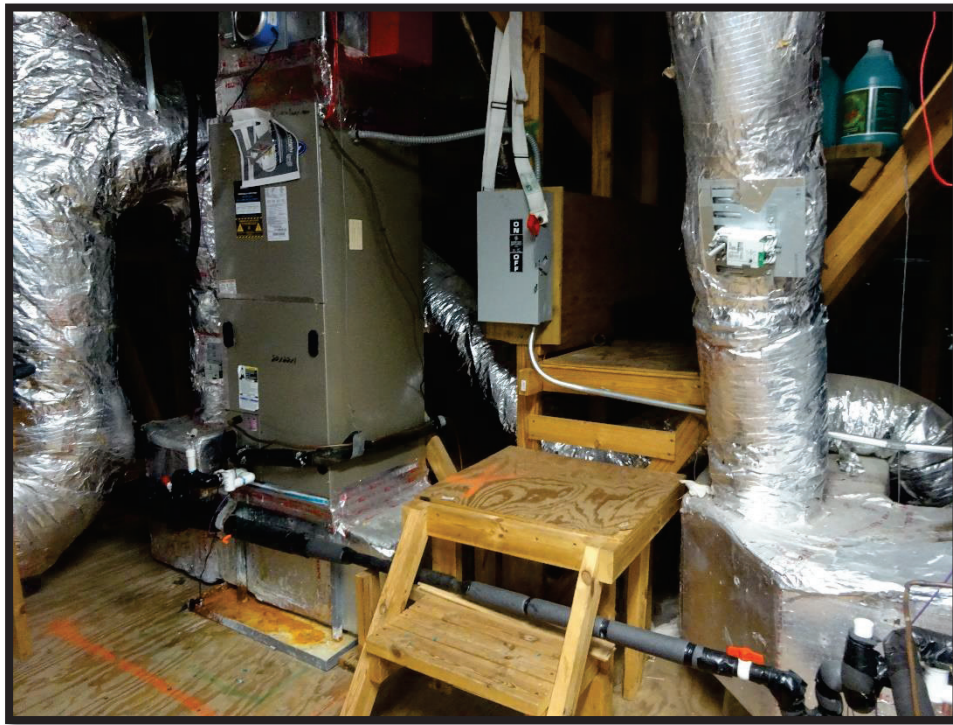
Photo 10 Typical interior vertical air handling unit.
