Harbor Bay Community Development District  
c/o Governmental Management Services - Tampa  
4530 Eagle Falls Pl  
Tampa, FL 33619

| Cause of Loss: | Hurricane Milton |
| McLarens File: | 009.023748.MI |

McLarens, on behalf of multiple carriers, requested that Halliwell Engineering Associates (Halliwell) perform an investigation of damage associated with a named weather event, Hurricane Milton (the Event) to a Resort Property. The loss location is the Resort Property located at 107 Manns Harbor Drive, Apollo Beach, FL 33572, identified as (the Property).

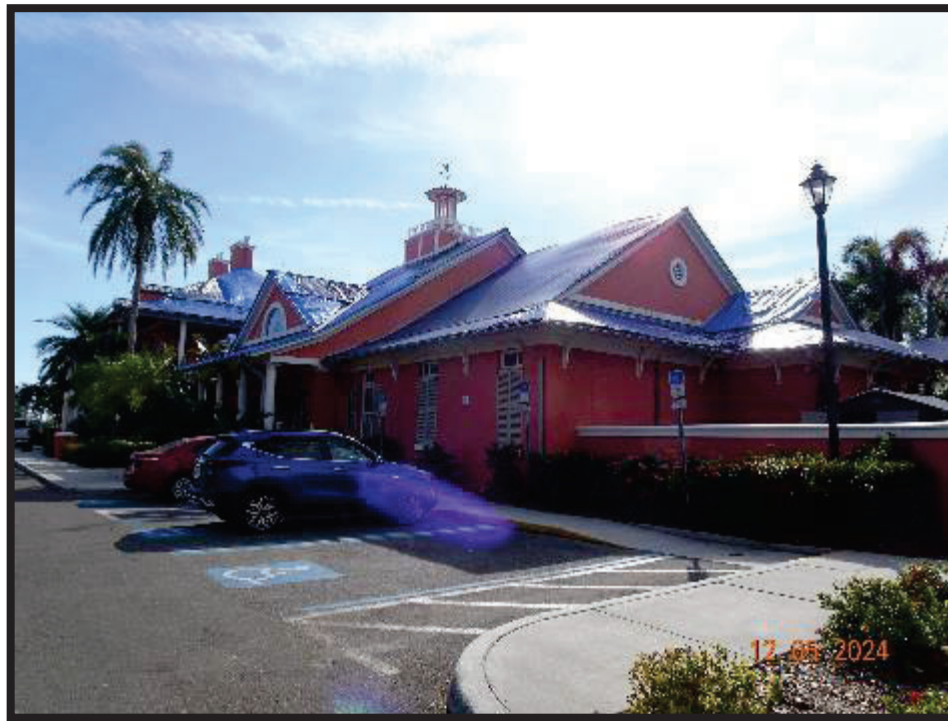
**Photo 1** View of the Main building at the subject property.

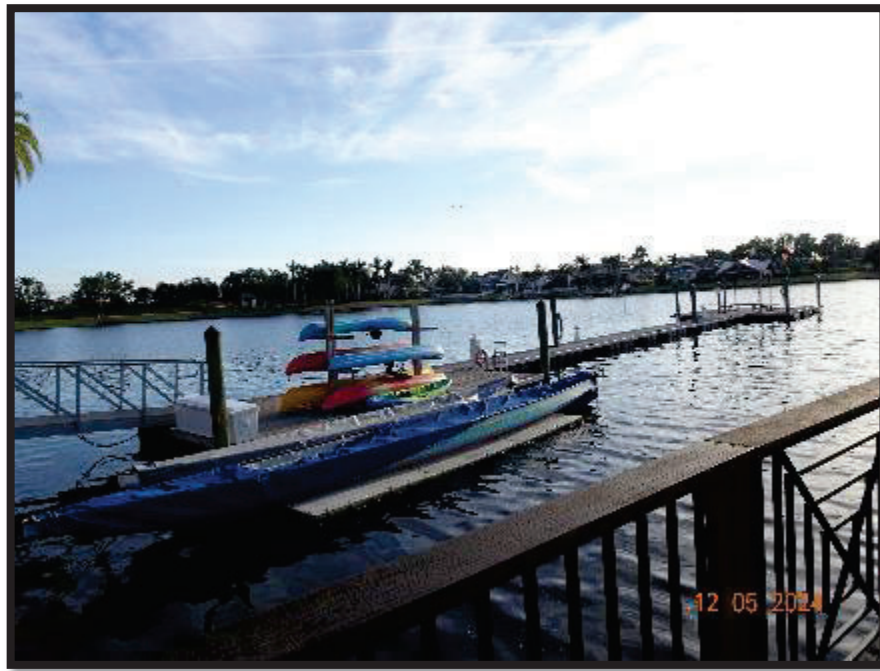
**Photo 27** View of the floating dock system along the south end of the marina.

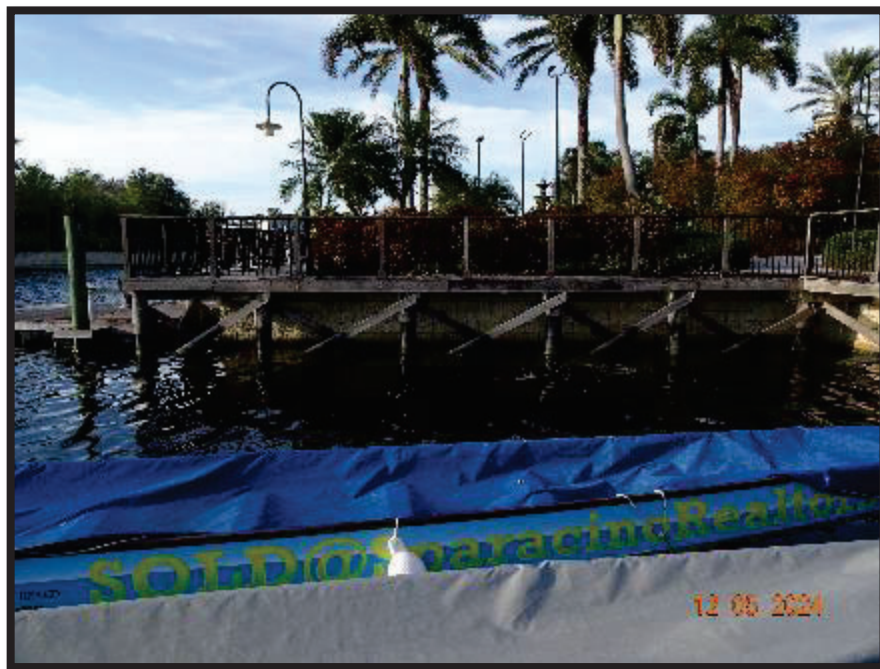
**Photo 28** View of fixed dock systems along the north end of the marina.
